MARINE SAFETY LESSONS LEARNED

Lessons Learned 01-19

Avoid delays and keep your ship on schedule! **Does your BilgMon 488 Bilge Alarm / Oil Content Meter operate properly?**

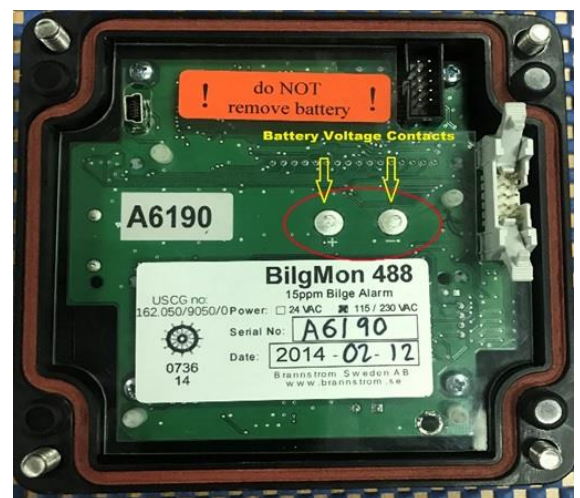
The specific monitor in these cases was the BilgMon 488 model manufactured by Brannstrom, a Swedish company. The older model, BilgMon 488 shown on the right, has a battery that is not replaceable by the crew inserted behind the circuit board of the Bilge Alarm. The purpose of the battery is to maintain the stored data and Real Time Clock (RTC) when the unit is disconnected from a power supply. The circuit board contains two contact points which provide the ability to measure the battery voltage. In all four cases, the battery voltage was extremely low and failed to provide the required 2.5 volts necessary to maintain the stored data without error. As a result, when the data was viewed on the LCD screen it was scrambled and inaccurate. The operator's manual for this model clearly states that, under no circumstances should the battery be removed. Furthermore, a red warning sticker is affixed to the circuit board as pictured above. Attempting to remove the battery in this circumstance may cause an unrecoverable error, failure and data loss. A manufacturer's representative indicated that the battery was originally designed to last the lifetime of the device and that if the RTC stops due to a power supply

failure combined with a low back-up battery voltage, the unit is locked down and the display reads "RTC check: FAILED." [Click here for the applicable manual.](#)
