Special Edition 2024

LOOKOUT

Containership Collision with Gantry Crane

Navigation Accidents Caused by Defective Voyage Planning

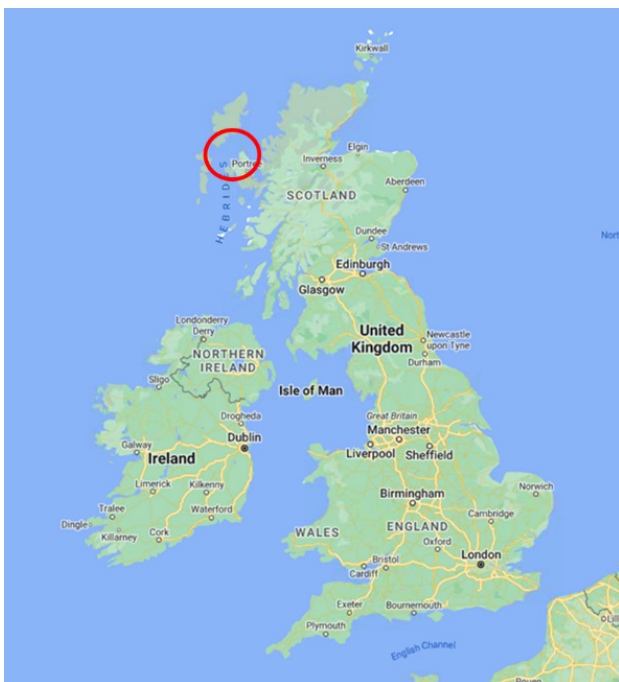
Figure 1: Location of grounding

On 23 March 2020, the general cargo vessel *Kaami* (2,715 tons, 89.95 metres in length) was on a course from Drogheda, Ireland, to Slite, Sweden, when the ship ran aground on Stgeir Graidach shoal in the Little Minch off the west coast of Scotland. The Master did not use the route recommended by the IMO and instead selected a course based on previous experience from a voyage on a different vessel.

This accident was the result of the failure to use a sufficient volume of data during the appraisal step of the voyage plan preparation process, resulting in the establishment of an erroneous course. Furthermore, there were many deficiencies and oversights involving the execution and monitoring of the plan (see Figures 1 and 2).

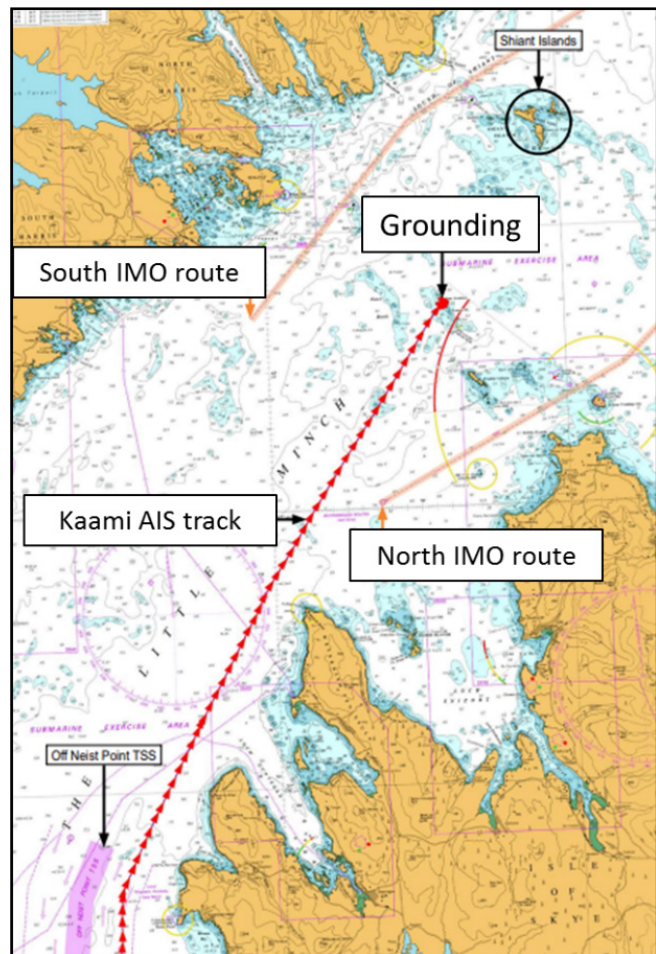
Figure 2: Kaami's track

Just before 2300, the chief officer and an able seaman arrived on the bridge to relieve the Master. At 0058, the chief officer notified the Coastguard that the ship was approaching reporting point "F", which is the start of the IMO recommended northerly route. However, the *Kaami* did not use the recommended route and instead used a route about one nautical mile north of Eugenie Rock, which was the planned track.

The *Kaami* ran aground because the voyage plan was configured to take the ship over an area with dangerous obstacles. The Master had passed through this area before. When preparing the voyage plan, he relied on his previous experience concerning the weather, sea conditions and other considerations. In addition, he only used the *Kaami*'s electronic navigation chart (ENC) data.

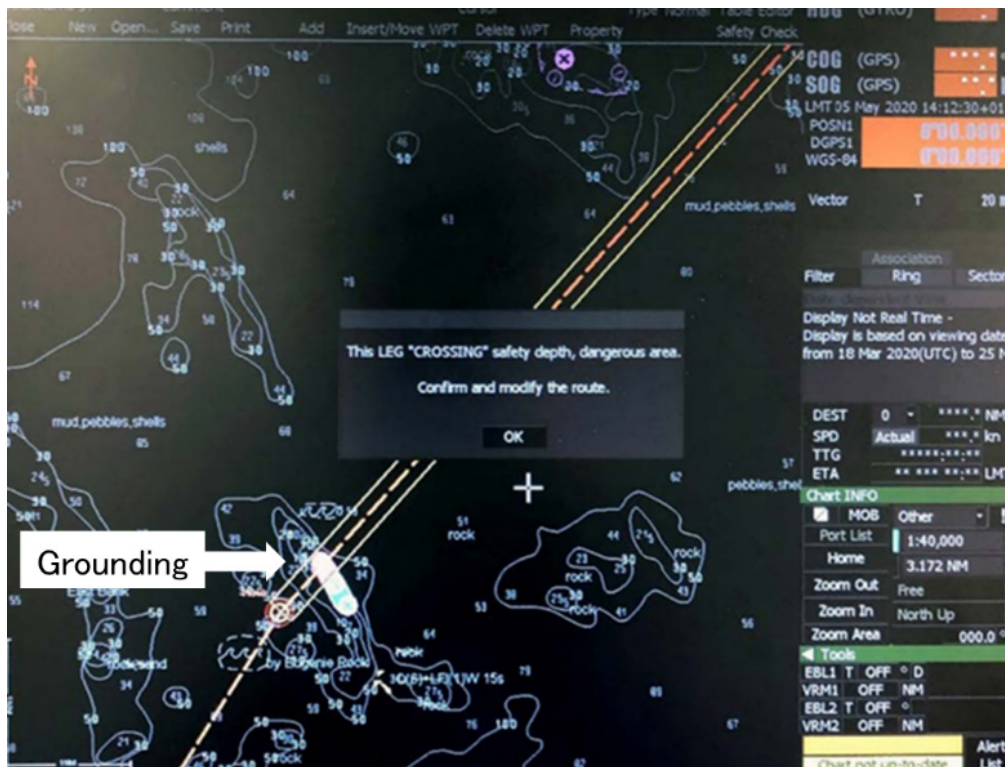
Figure 3: The ECDIS safety check displays the following warning in the centre of the screen: This Leg “CROSSING” safety depth, dangerous area. Confirm and modify the route.

The Marine Accident Investigation Branch (MAIB) was unable to ascertain whether the ship had used the ECDIS safety check function (see Figure 3). When a safety check was conducted after the accident, it revealed 479 errors (hazards) on the route. The ECDIS safety check function is an extremely effective way to supplement visual checking.

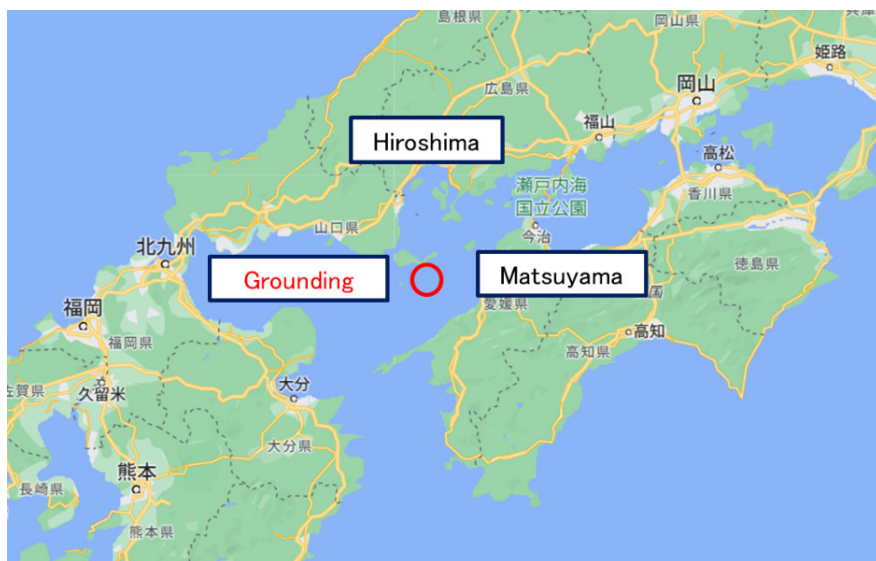
On the morning of 10 January, *Inazuma* departed the Innoshima Island shipyard for a test run after the completion of maintenance work. The ship planned to turn back near where the grounding occurred in order to return to the MSDF base at Kure. The screw apparently hit a rock or other objects and there was a small oil leak. Repairs are expected to take a few years and cost about 4 billion yen.

Figure 4: Location of the grounding of the Inazuma (Google map background)

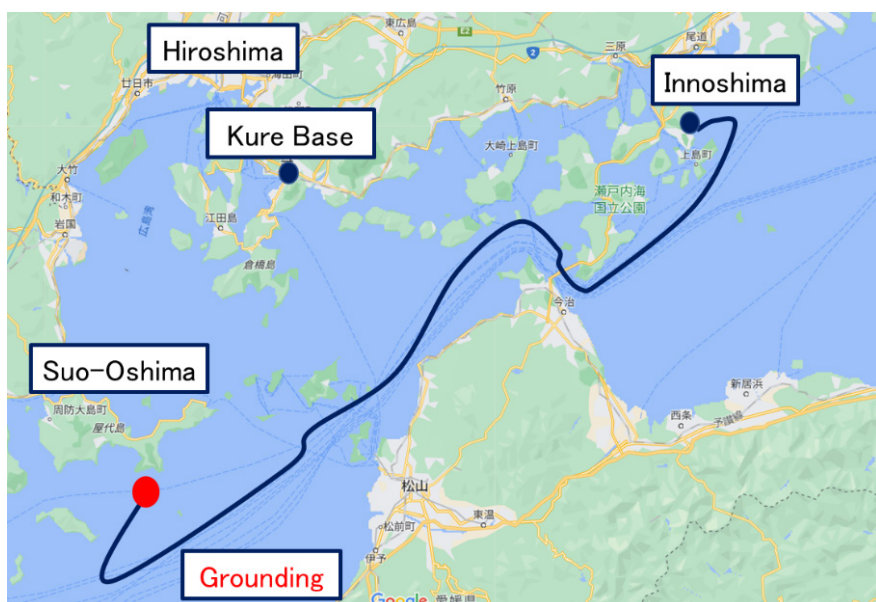
After the *Inazuma* completed testing at about 1135, the captain ordered a revision to the voyage plan but failed to follow adequate safety measures:

Figure 5: Estimated route of the Inazuma and location of grounding (Google map background) (Prepared by the author based on media reports)

The crew of a ship frequently revises a voyage plan while under way for a variety of reasons. Changing the voyage plan involves the same four steps that are used to prepare the original plan: appraisal, planning, execution and monitoring. On the *Inazuma*, the captain made a sudden change in the voyage plan, but an appraisal of the new plan was not conducted. This process should have included checking for shallow areas and other hazards in the new course, positions of nearby ships, and other considerations. In addition, as part of bridge resource management, the captain and navigator must constantly confirm the receipt of advice and other input from subordinates. This accident is an example of the result of a defective process used to determine a voyage plan, as well as poor bridge management.

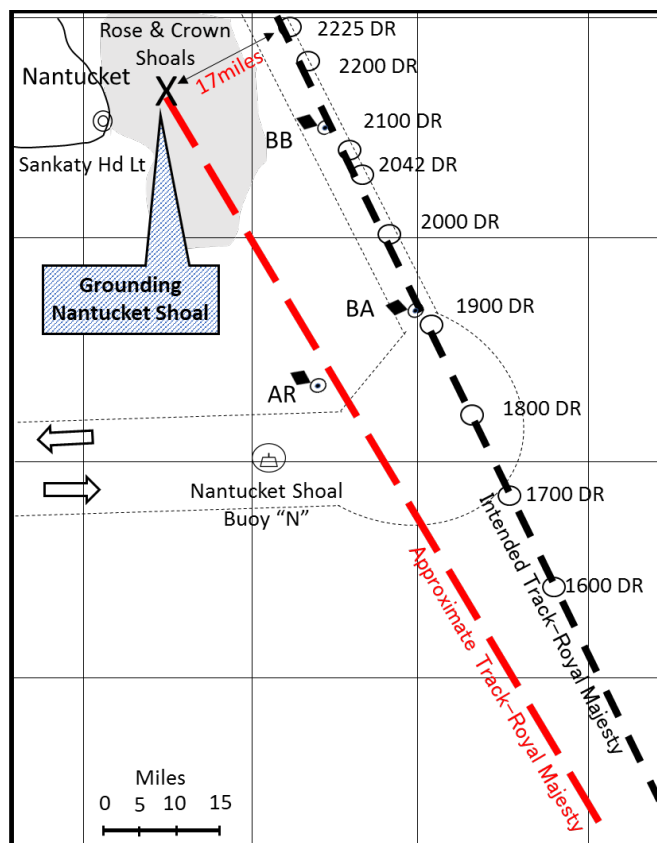
Figure 6: Course of the Royal Majesty (prepared by the author based on the investigation report)

The crew's failure to detect for more than 34 hours that the ship was not using GPS data raised serious concerns about the performance of the watch officers and the Master. The chief officer and second officer were on watch prior to the grounding and failed to realise that the *Royal Majesty* was not following the voyage plan, despite several indications of trouble. This was gross negligence.

The direct cause of this accident was the loss of GPS position data. Moreover, the navigator failed to cross-check the ship's location by using the two methods that are used when GPS position data is lost. Nonetheless, all members of the bridge team were guilty of significant negligence as well as numerous small errors. The bridge team was unable to break the chain of errors and the result was the grounding of the ship. This accident underscores the importance of the using suitable measures to frequently monitor a voyage in order to have accurate information about the status of the voyage at all times.

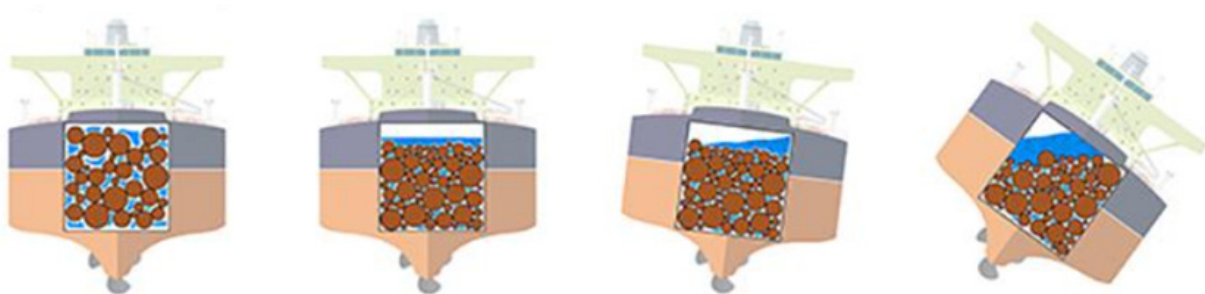
Note 2: Dynamic separation of cargo can occur during a voyage when engine vibrations or the ship's movements cause compaction of the cargo from underneath. The resulting pressure pushes the water in the cargo to the surface. As a slurry consisting of water and fine particles accumulates on the surface of the cargo, the free water effect occurs within the hold. As a result, the apparent metacentric height (GM) decreases. Over time, the movement of this slurry causes the loosened cargo to become unevenly distributed within the hold, such as by building up on one side. This can cause the ship to tilt. If the free water effect on the surface of the cargo increases, a ship may even capsize.

Figure 1: How dynamic separation can cause a ship to tilt

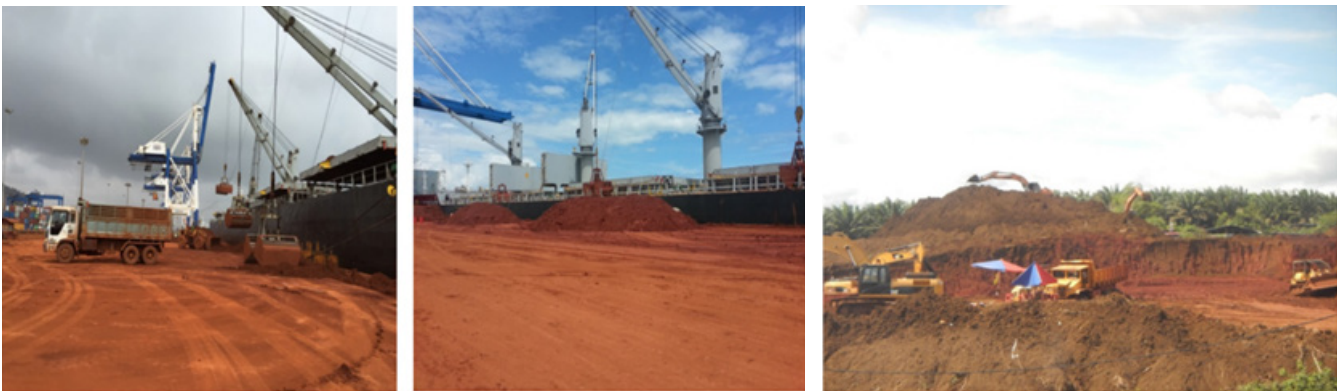
The shipper’s Cargo Declaration stated that the moisture content was no more than 10%. However, this was very unlikely because of the heavy rain prior to the start of the loading operations and the conditions of the mining, transport and storage operations for the bauxite.

Ten tests of bauxite samples were conducted between 17 and 30 December. The average moisture content was 21.3%, which was 11.3 percentage points higher than the figure in the Cargo Declaration. The operators of the *Bulk Jupiter* were not aware of the results of the tests.

Figure 3: The bauxite open-pit mine at Kuantan and loading on the *Bulk Jupiter*

- The Master must be aware of the cargo schedule of the IMSBC Code
- Documents concerning the cargo must be received (Cargo Report, TML certification, moisture content declaration, etc.)
- If necessary, the Master or an agent must test the cargo
- Group A cargo should not be loaded in the rain.

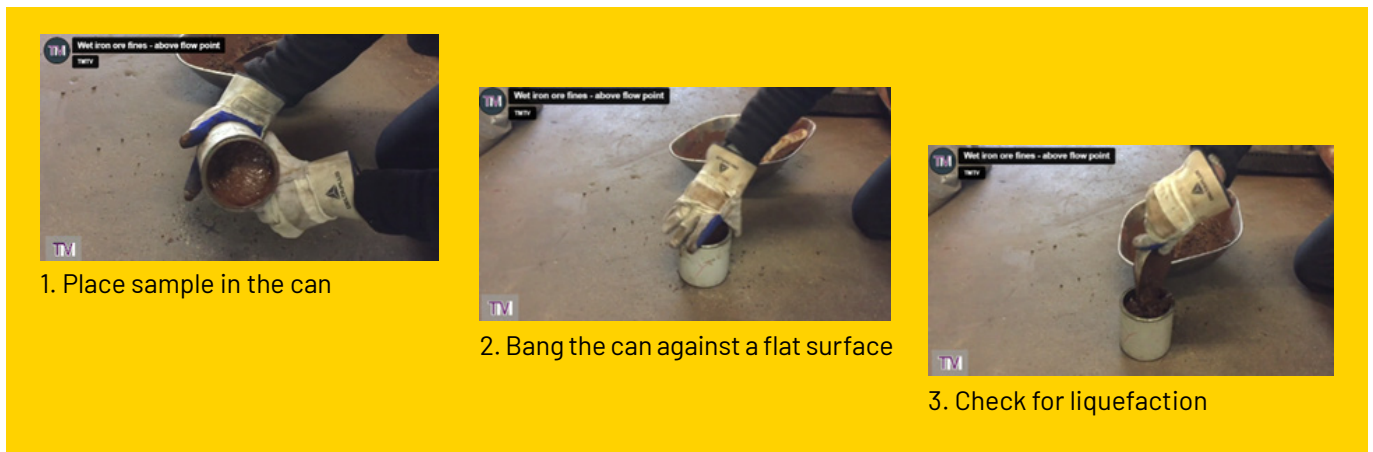
Figure 4 : Can test

Note 3: A can test involves a wet sample of the cargo being placed in a can to a height of about 20 centimetres and the can then being banged against a hard, flat surface 25 times at intervals of one or two seconds. The test is used to determine if liquefaction of the sample is possible.

IMSBC Code 8.4.2 states that: “If samples remain dry following a can test, the moisture content of the material may still exceed the Transportable Moisture Limit.” Therefore, the can test can be used on the ship to determine the possibility of liquefaction. At the very least, cargo that does not pass the can test should not be loaded on the ship.

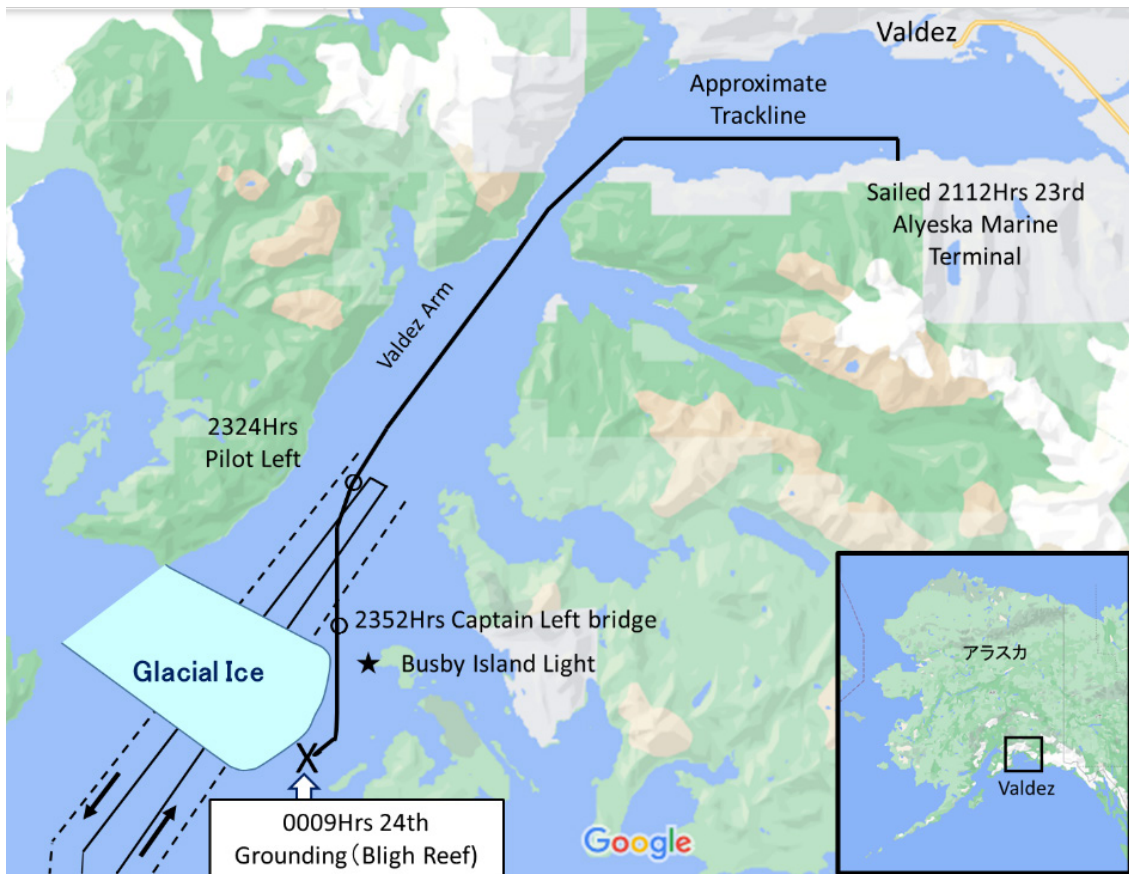
Diagram 1: Location of the grounding of the *Exxon Valdez*
(Source: NTSB/MAR-90/04)
