UK P&I CLUB

RISK FOCUS: ENGINE ROOM FIRES

The majority of onboard fires originate in the engine room

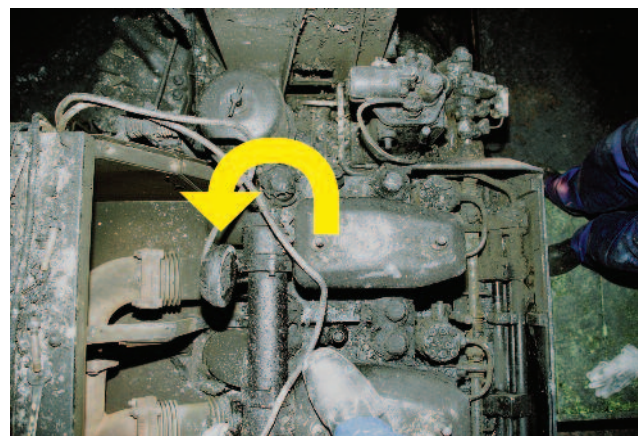
Potential route for hot oil vapour to spread from the hot box enclosure to the exhaust enclosure (cladding/covers removed for inspection)

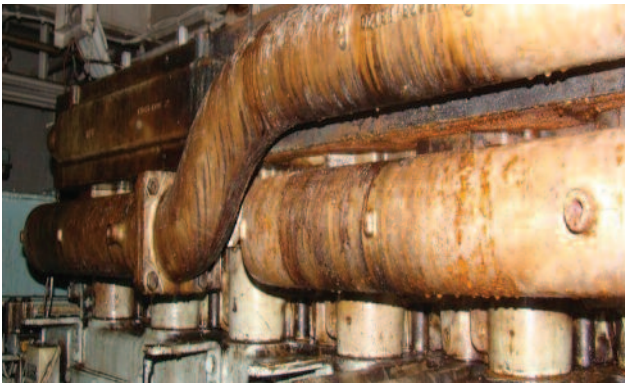
Exhausts completely uninsulated

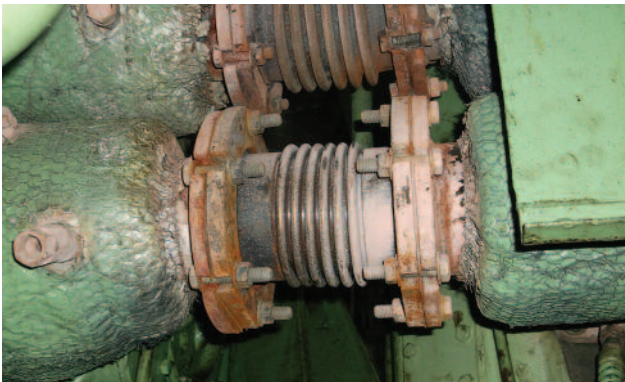
Exhaust bellows exposed

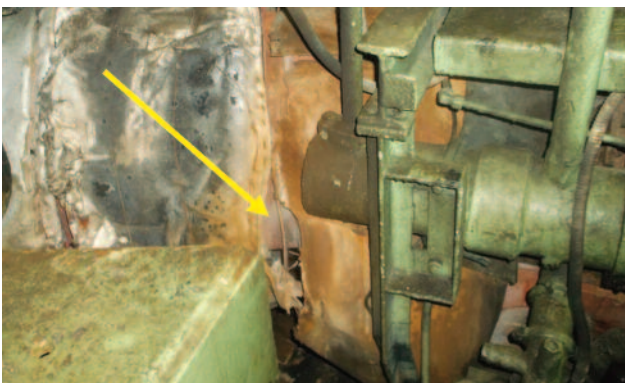
Small portion of exhaust surface exposed (as arrowed)

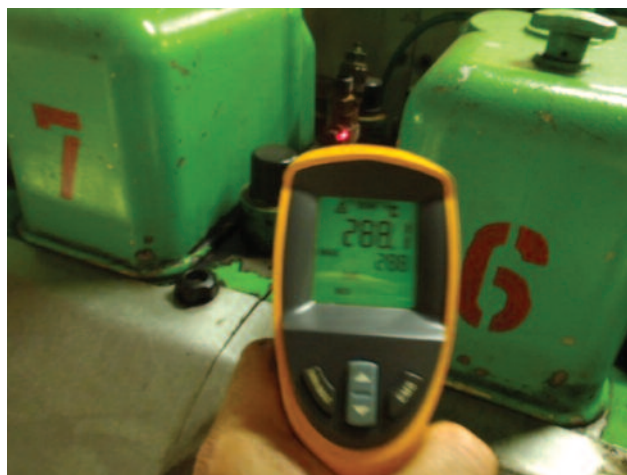
Uncovered indicator cock with exposed temperature above SOLAS limit

Indicator cocks are another potential source of ignition. IMO MSC.1/Circ. 1321 Para 1.1.5 recommends that "Exposed indicator cocks should be insulated in order to cover the high temperature surface."

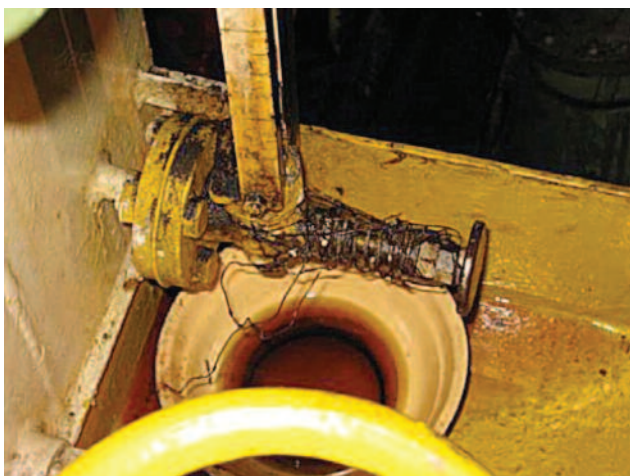
The UK Club's ship inspectors regularly find that various methods are used to keep these valves permanently in the open position. Chocks of wood, pieces of wire and purpose made clamps are often seen to be used to for this purpose. This is dangerous practice. If a gauge glass breaks in a fire the entire contents of the tank will leak into the burning area, escalating the fire.

Self-closing gauge glass valve gagged with wire

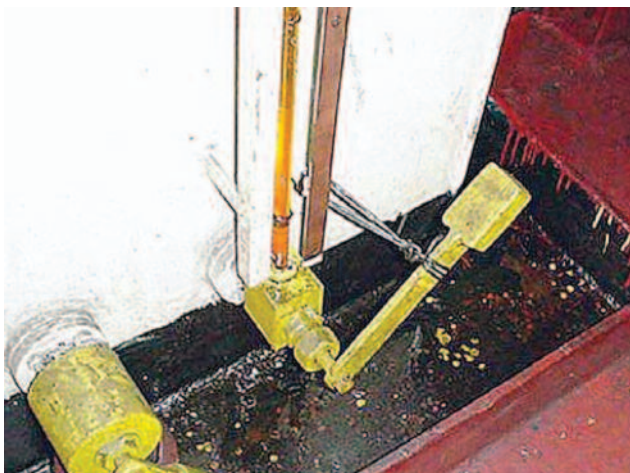
Self-closing gauge glass held open with string

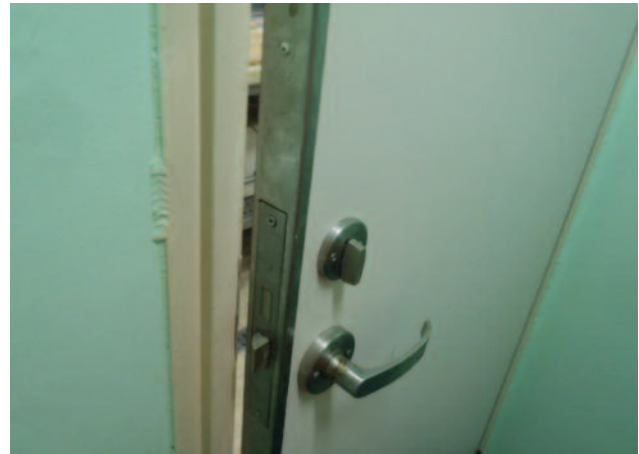
Fire door failing to close

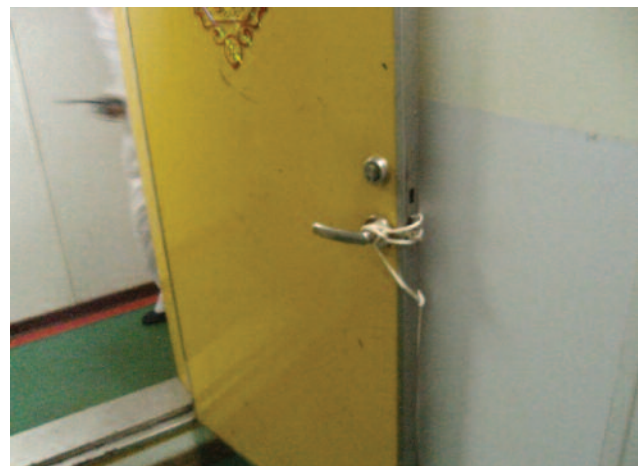
Fire door tied open

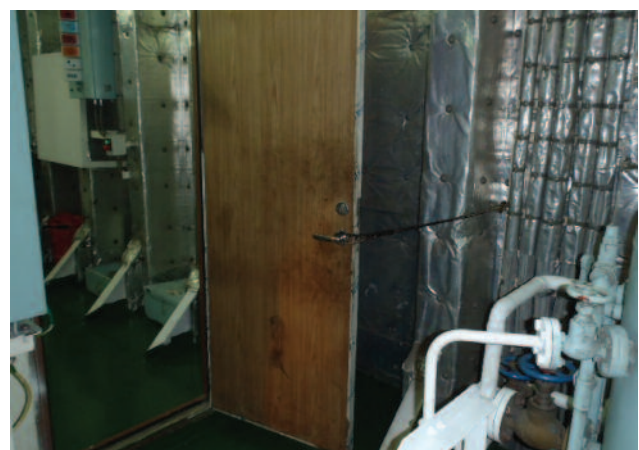
Fire door tied open

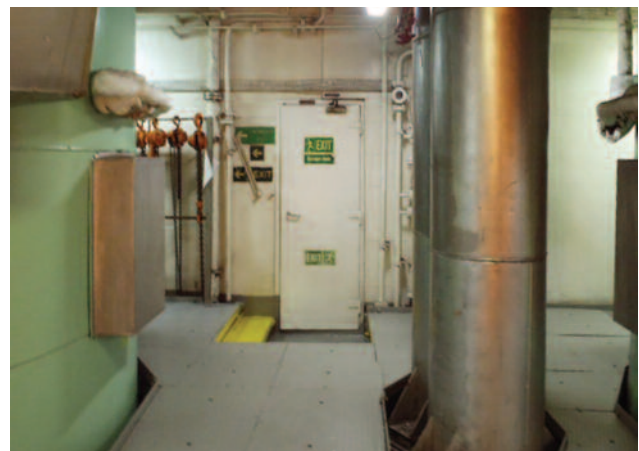
Poorly marked escape route and door

Technical Bulletin No. 39/2007 also recommends that the exit doors are clearly highlighted. In both the above photographs, it can be seen that white painted doors do not stand out well against white painted bulkheads. Doors painted with “tiger stripes” or marked with retro reflective tape are far more obvious.
