# RISK FOCUS: HATCH COVERS

# Are the ships' hatch covers weathertight?

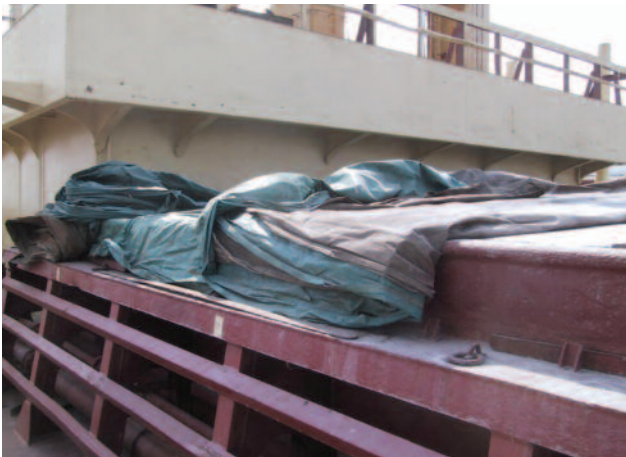
**Different plies of tarpaulins used for making hatch covers weathertight**

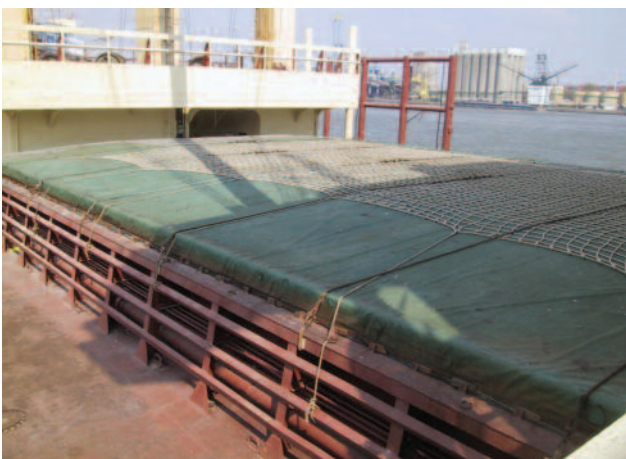
**Tarpaulin type hatch covers, properly battened down and ready for going to sea**

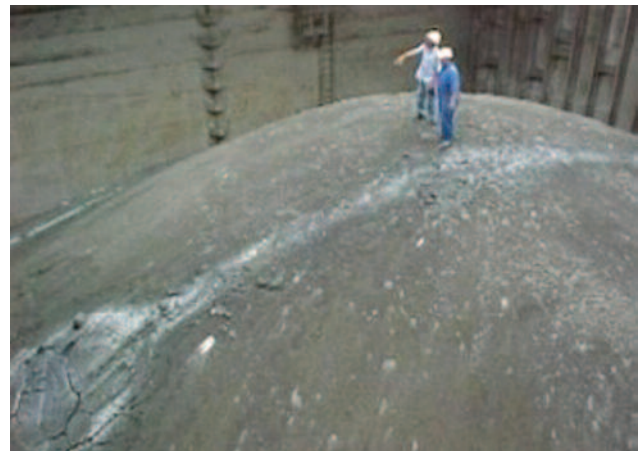
**Evidence of leakage in way of the hatch cover cross joints**

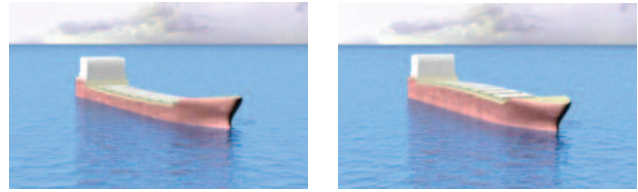
### Showing ship deflections

In order to understand the difficulties related to design, it is important to know that ships are subject to different deformations when in port and at sea. These distortions are brought about by loaded/empty/ballast conditions as well as flexing and twisting of the hull as a result of wave action, which all have an influence on the hull form and eventually, the hatch covers.

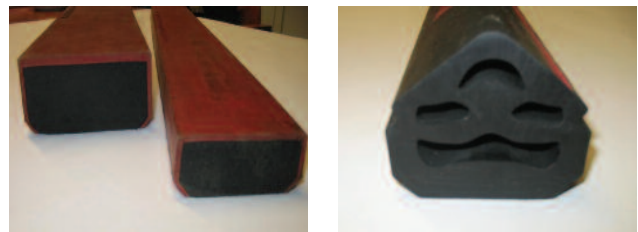
Different types of packing rubbers (from left to right: Sponge rubber, CAT or Sliding seal and Flex seal)

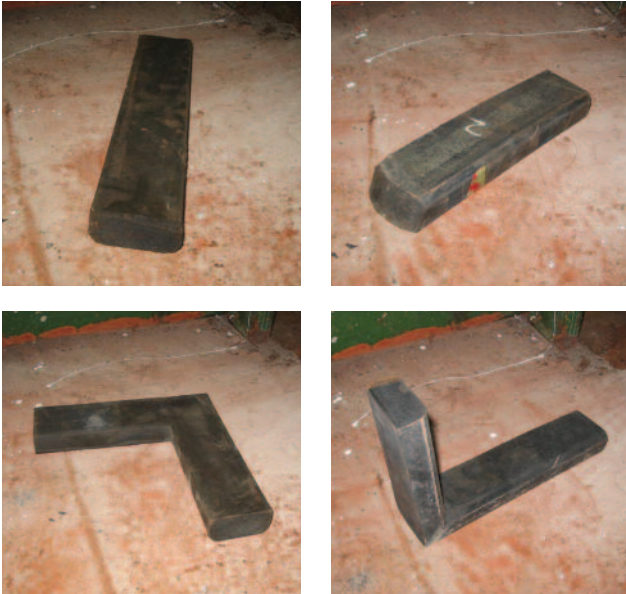
**Different shapes of packing rubbers (from left to right: linear rubber, end piece with solid nosing, flat corner and vertical corner)**

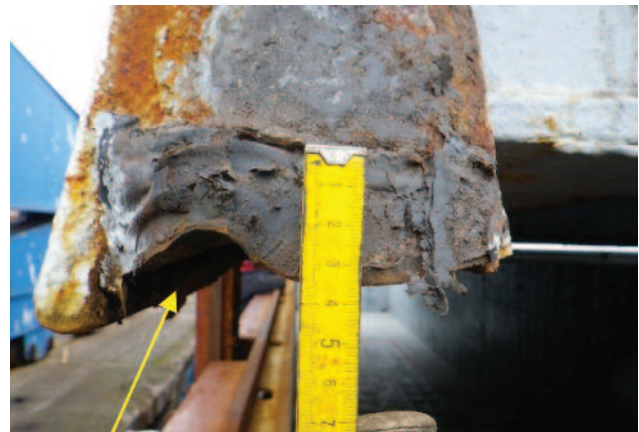
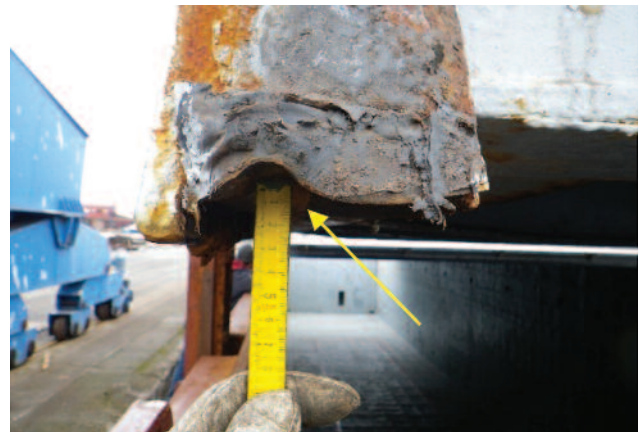
Overcompression of the packing rubber will result in permanent damage over time. This will become apparent in the form of a set groove in the impact area between the packing rubber and compression bar, as shown in the following images.

**Deep permanent groove in packing rubber as a result of overcompression. Also note the off-centre permanent imprint**

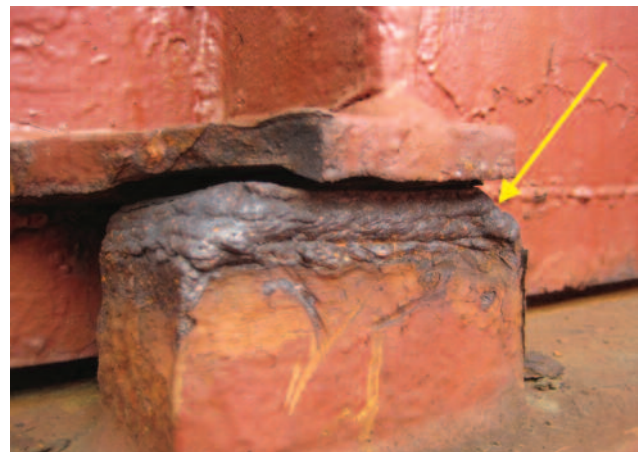
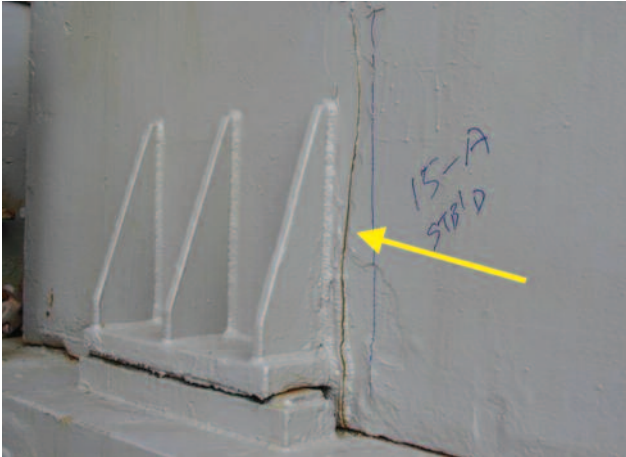
**Improper repairs to bearing pad and a crack developing in the hatch panel side plating due to advanced bearing pad wear**

Bearing pads are fine pieces of engineering and replacing them with non-original spares or non-compatible steel could result in serious problems. Far too often bearing pads are replaced or repaired by the ship's crew with only one thing in mind, i.e. restoring the height of the bearing pads, whereby the correct size and use of appropriate material for the mating surfaces is overlooked. For bearing pad adjustment, it is

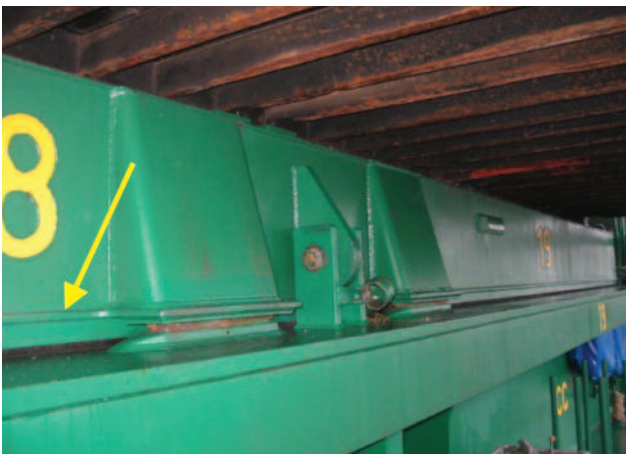
On hatch covers that are equipped with bearing pads, an operational clearance in range of 10-15 mm will generally be present between the panel side lower edge and coaming. The exact distance should be checked with the manual and clearly noted on inspection sheets as it is one of the first indicators of bearing pad wear down.

**Operational clearance between the lower edge of the panel side plating and the coaming table**

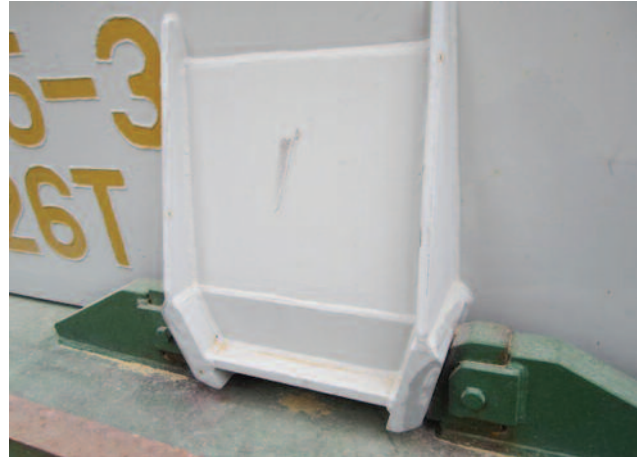
**Properly maintained and adjusted locator**

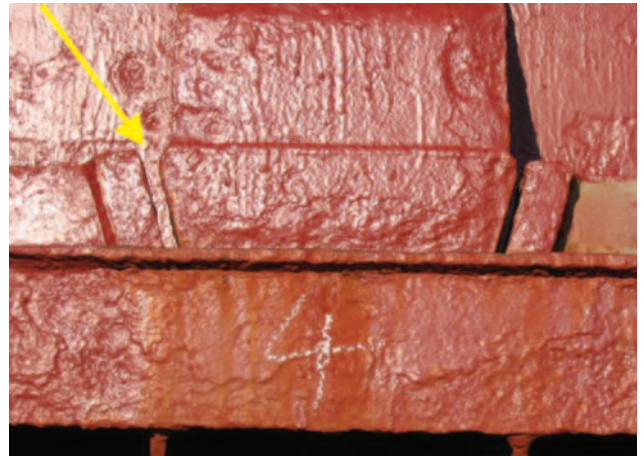
**Excessive wear on locator**

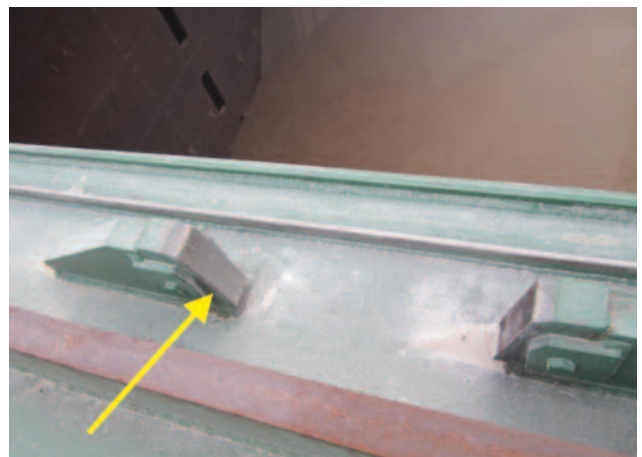
More recent designs of locators have replaceable mating surfaces and allow for the use of shim plates, which facilitates installation and adjustment in case of wear down.

**Replaceable locator pads**

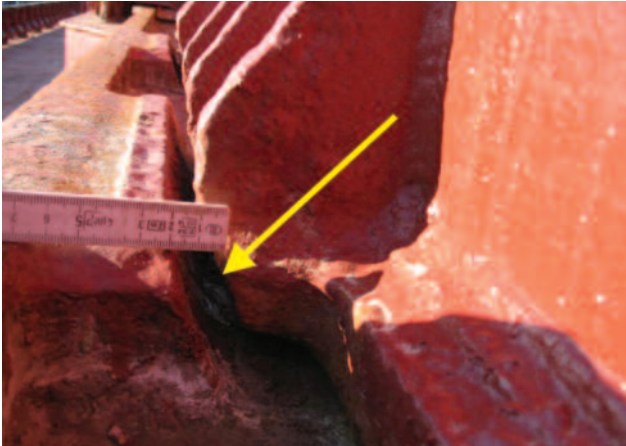
**Excessive clearance in way of stoppers**

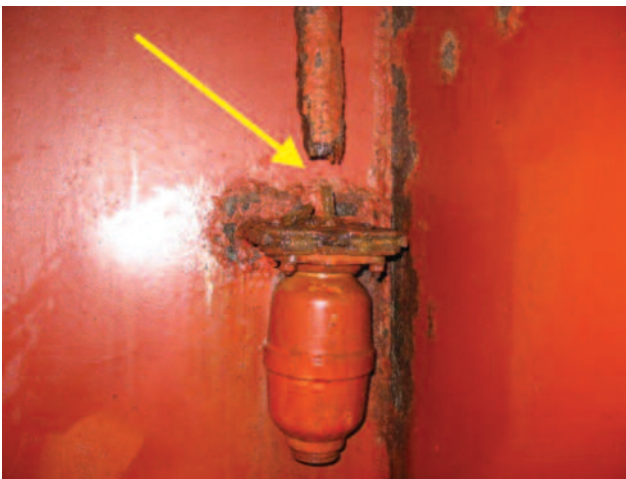
**Corrosion wasted drainpipe**

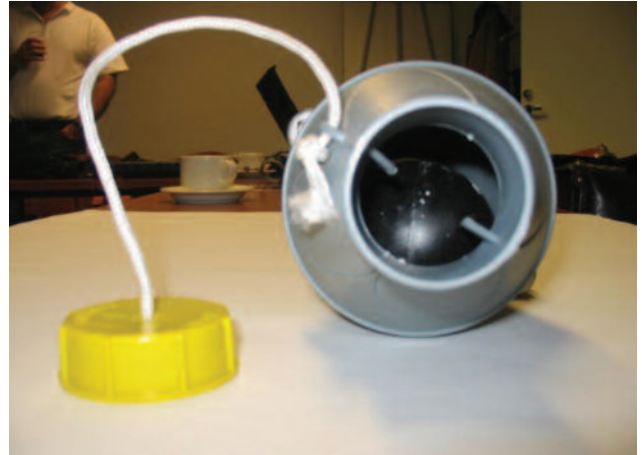
Also, in heavy weather, with waves crashing over the deck and hatches, there is a risk that water will be pushed into the drain pipe and infiltrate the hold, causing wetting damage to the cargo. To prevent this from happening, drain valves should be equipped with a non-return system that needs to be checked and maintained.

**Drain valve with ball inside acting as non-return system**

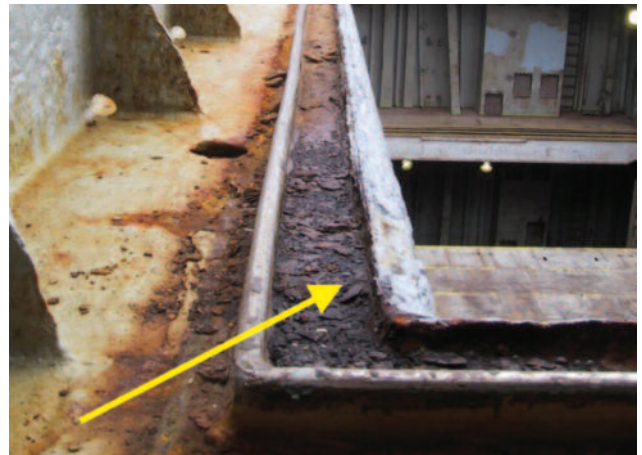
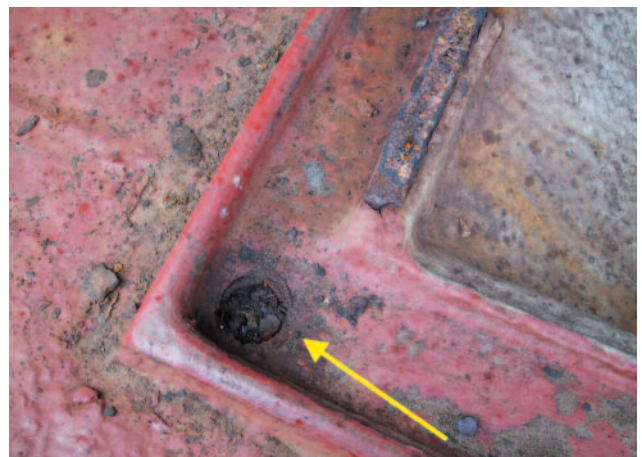
**Presence of rust and debris will eventually lead to the clogging of the drain hole/drain pipe**

Proper maintenance should include regular cleaning of the drain channels (as well as drain holes, drain pipes and drain valves), especially after completion of cargo operations when spilled cargo may have accumulated in the drain channels and drain pipes.

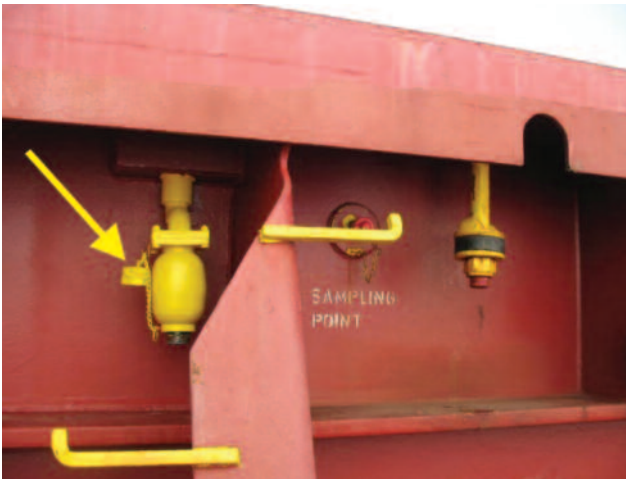
Finally, in order to keep extinguishing gas (CO<sub>2</sub>) in the hold and/or prevent outside air from entering in case of a cargo hold fire, drain valves should be fitted with so-called "fire caps", which allow the drains to be closed off. Also, in case of fumigation, these caps should be fitted in order to seal off the cargo compartments.

Drain valve (yellow) with threaded fire cap firmly connected by a lanyard

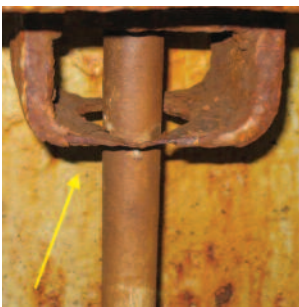
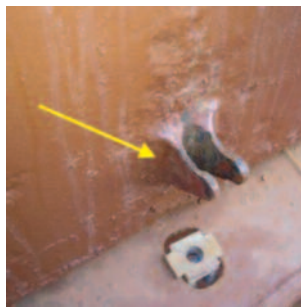
Corrosion and diminution of a quick acting cleat crutch and thinned down snugs

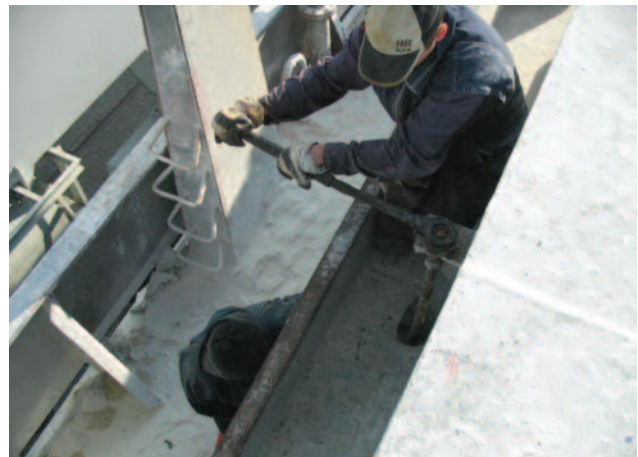
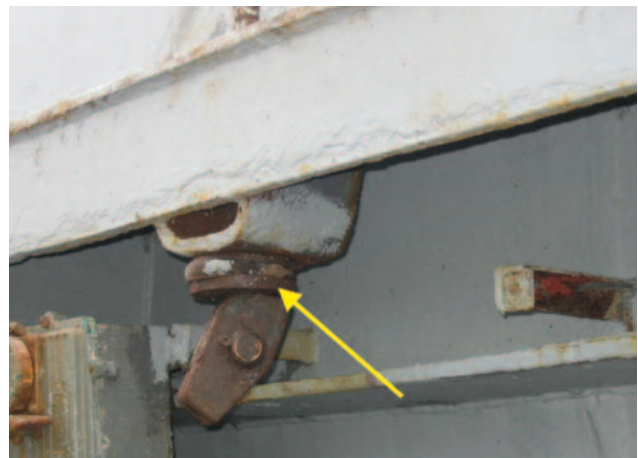
The primary function of the cleats is to hold the panels down when the ship is at sea. However, as there will be relative movement between the panels and coaming, cleats should also cater for some movement. In many cases where ships fail an ultrasonic or hose test, the crew is seen to tighten up the cleats with spanners, cheater bars, etc. However, it is important to know and understand that cleats should never be overtightened to obtain a tighter seal. Excessive tightening makes the system too rigid and eventually results in the cleats becoming damaged. In view of the steel to steel contact between panels and coaming, it would be impossible to compress the rubber packing further once steel to steel contact has been achieved.

Overtightening of securing arrangements and crew member overtightening cleat with a spanner and cheater bar (top) until the rubber washer is reduced to pancake size (bottom)

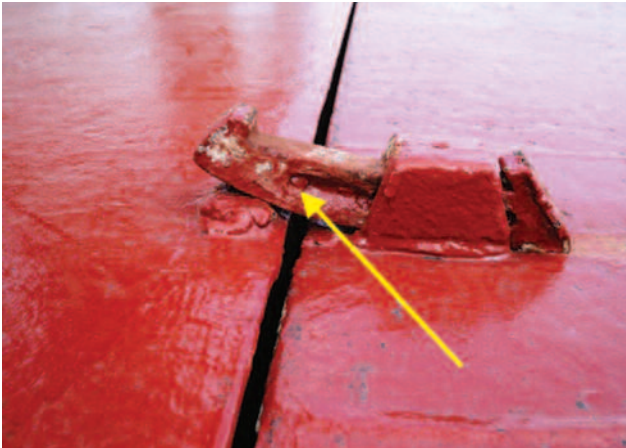
“Banana” shaped cross wedge

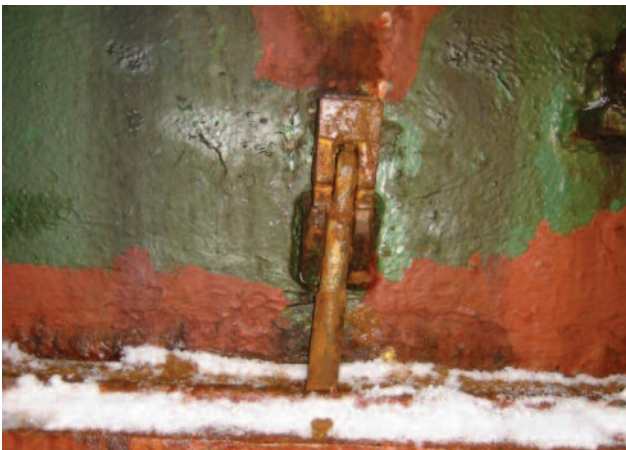
Crooked quick acting cleat (improper vertical alignment)

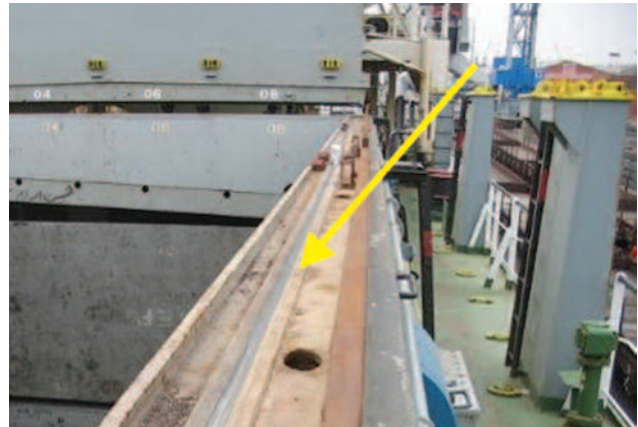
A variety on the traditional compression bars are the flat steel mating surfaces which are used in combination with “sliding” type seals. In many cases the steel coaming plating can act as the mating surface for sliding type seals, however, it is best to weld a stainless steel strip on the coaming table as the smooth surface will contribute to the longevity of the seal during its in-service life.

Stainless steel mating surface for sliding type packing rubber on coaming

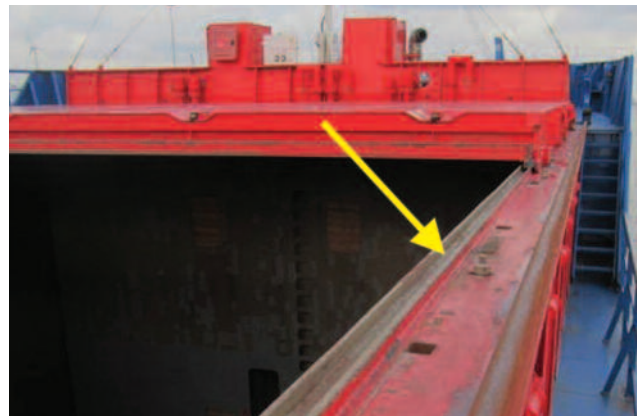
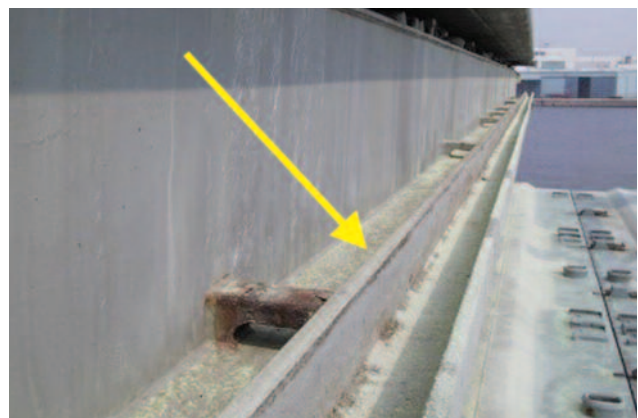
Taking into consideration the compression force that acts on the rubber packing, sharp edges can easily cause damage to the packing rubber. This is the reason why the sealing surface of the compression bars should be round shaped and not square. Replacing damaged sections of compression bars with ordinary steel flat bars (often seen in cases of stevedore damage) should be avoided.

Round shaped (top) and square shaped (bottom) compression bars

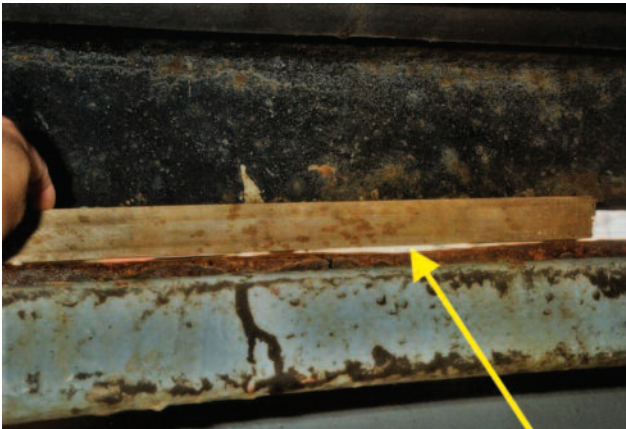
Whilst some limited tolerances are allowed with regards to straightness (these are generally stipulated in the maker's manual), waviness (either + or -) will lead to over or under compression of the seal, both of which should be avoided). Taking into consideration that design compression is a matter of millimetres (generally in the range of 10-12mm), even slight unevenness or waviness by a few millimetres represents a significant percentage of lack of compression or overcompression.

**Compression bar waviness will result in loss of compression**

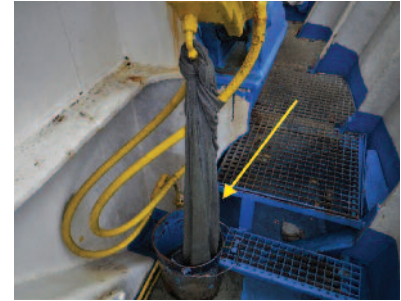
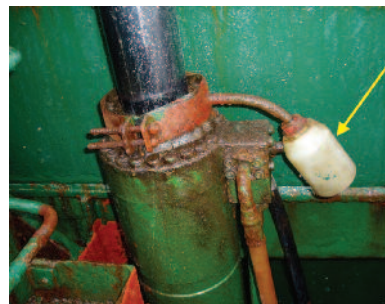
**Temporary repair (rubber patch and jubilee clip) and shipboard made systems to contain hydraulic oil leakage from hydraulic piping and cylinders**

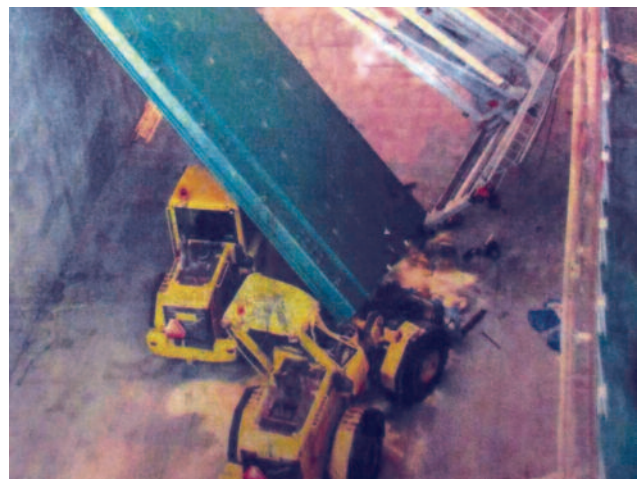
**Improperly maintained or wrongly operated hatch covers can result in serious damages or accidents**

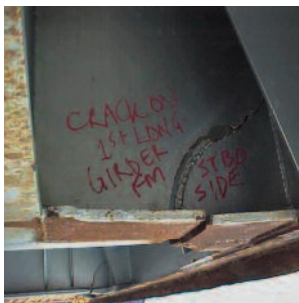
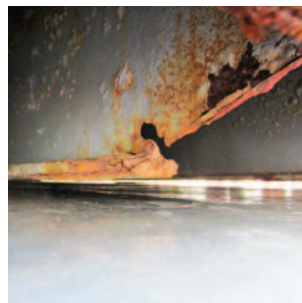
Both advanced corrosion and stress fractures (caused by improper maintenance, improper panel adjustment, bearing pad wear, overloading, heavy weather damage, etc) will affect the structural integrity of the panels. Therefore, the structural condition of the panels should be carefully monitored.

**Cracks and corrosion will affect the panel's structural integrity**

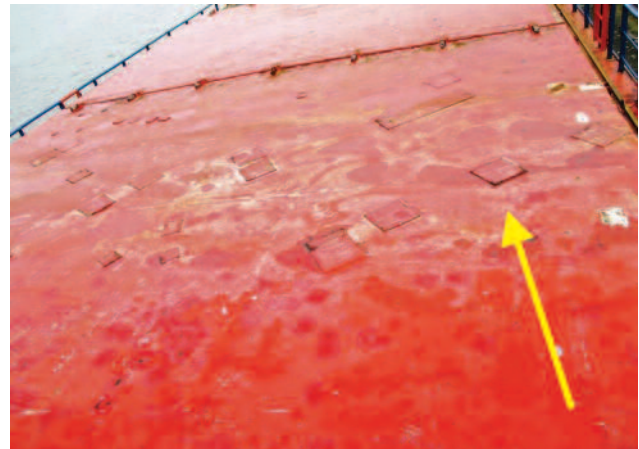
Sometimes panel damage like cracks or holes are repaired with doublers. Whilst doublers might, under certain circumstances, be acceptable as a temporary repair, they are never to be considered as a substitute to a proper insert repair. Doublers will actually cover up damage and prevent water ingress, but they will never restore the original strength or stop the corrosion process. Furthermore, welding work on hatch covers needs to be carried out by trained and qualified personnel as excessive heat during welding might cause distortion of the panel structure, which is very difficult to correct.

**Multiple doubler plates on the hatch top plating**

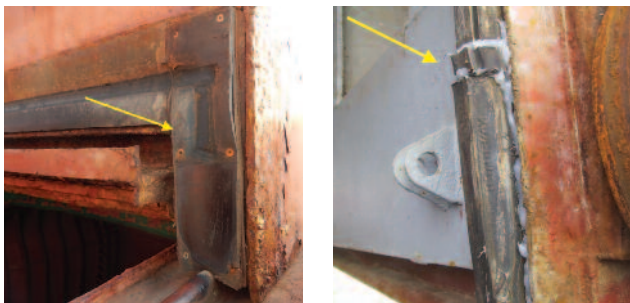
a hatch cover tightness test (which is generally carried out before loading water sensitive cargo). Short rubber packing inserts, applying backing strip on the packing rubber's sealing surface, use of silicon etc are frequently seen and considered as evidence of poor repairs.

**Backing strips (here nailed into the original packing rubber) and short insert repairs are frequently seen as evidence of improper repairs**

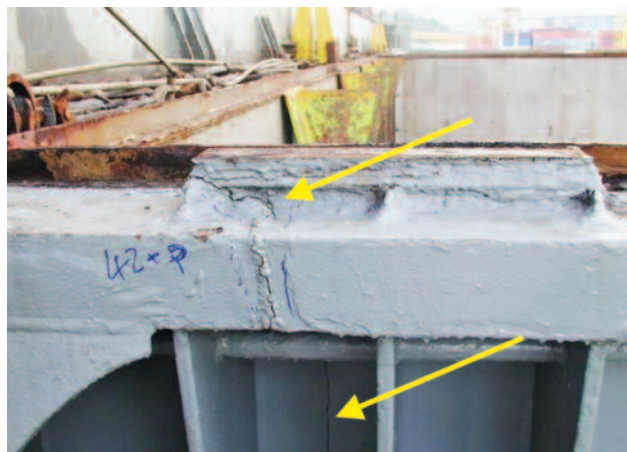
**Crack progressing from the landing pad into the coaming**

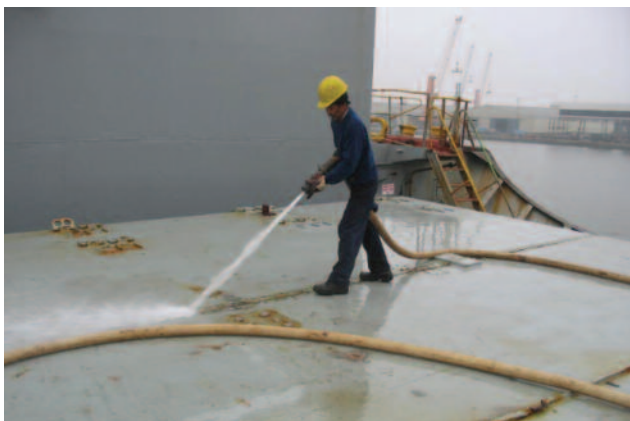
because the space between the top plating of adjacent hatch panels is very small and will cause the jet of water to break apart on top of the panels instead of entering the interpanel void space. In such a case, the absence of water in the hold would not be an indication that the sealing arrangements are in order, but merely the result of lack of water and hydrostatic pressure acting on the seal.

**Strong jet of water being applied to the cross joint**

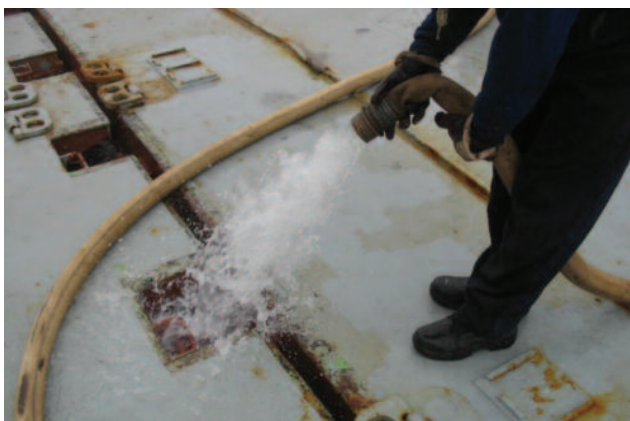
An improved testing method when carrying out hose tests with a view to assessing the integrity of a weathertight system (especially when delicate cargoes are to be loaded) would be to close the panel's side guttering and fill up the cross joint interpanel void spaces with water (with a fire hose without a nozzle, without applying a high pressure jet).

**Filling up of interpanel void space with water from a fire hose without a nozzle**

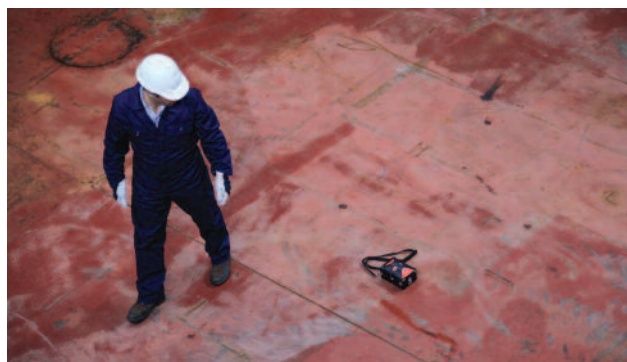
The ultrasound testing principle is quite simple. Ultrasound equipment for hatch cover tightness testing requires a transmitter and a receiver unit. The transmitter emits ultrasound and is placed in the ship's hold.

**Transmitter being placed in the ship's hold**

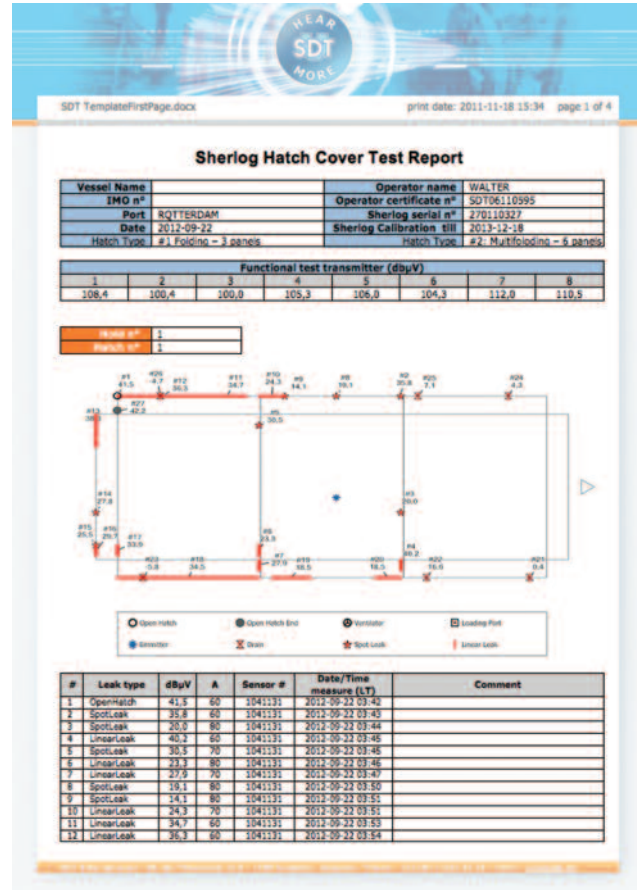
### Typical example of a hatch cover test report

The biggest advantage of ultrasound testing is that the test results give an indication of not only the contact with the packing rubber, but also the compression of it. If compression is good, then we know that the packing rubber has sufficient compression force, which means that the rubber packing will be able to compensate for relative movements and, as such, provide a tight seal. The fact that we can find out whether the rubber will perform well at sea whilst the ship is still in port provides extra safety. Moreover, in hatch cover tightness, compression is the governing factor and not contact.
