UK P&I CLUB

RISK FOCUS: ENGINE ROOM FIRES

The majority of onboard fires originate in the engine room

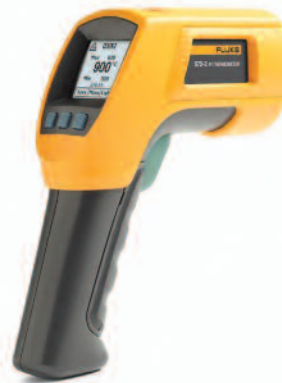
Infra-red temperature gun. On some instruments a laser beam pinpoints the target surface of interest, making for precise measurements and accurate temperature profiling. Slightly more expensive instruments provide a heat map image of the area of interest.

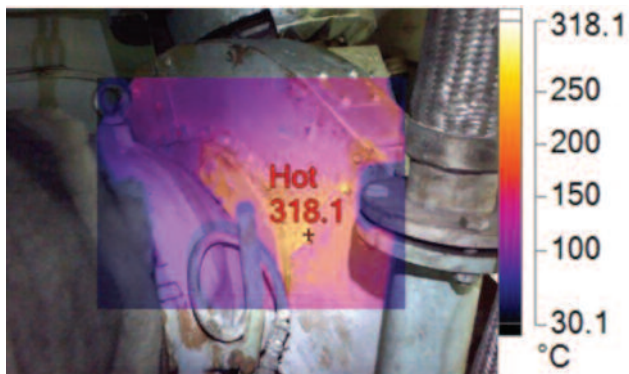
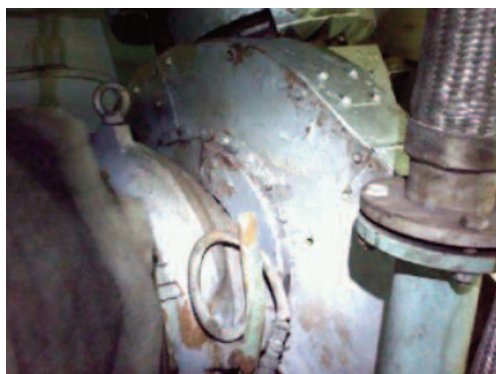
IR001153.IS2-NO1 Auxiliary engine

"Hot spot" due to missing insulation

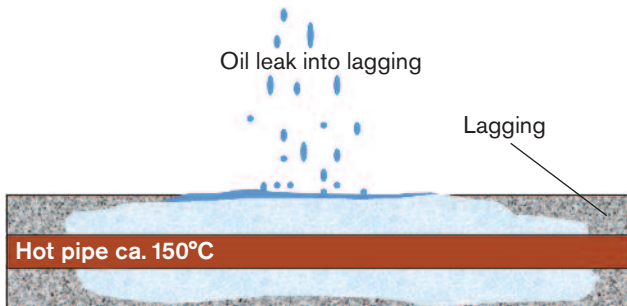
If mineral oils (fuel oil, diesel oil, lube oil) soak into lagging on pipe work operating at a temperature above about 150°C there is a risk that the oil will oxidise slowly within the matrix of the lagging and eventually ignite spontaneously, causing the lagging to disintegrate and oil from a persistent leak to ignite. This process can take many hours, and there may be little external warning of the imminent danger until smoke appears shortly before the fire becomes visible. It is essential, therefore, that oil leaks are attended to promptly and that permanent repairs, including the replacement of oily lagging, are made correctly rather than resorting to makeshift solutions.

Risk of 'spontaneous ignition'

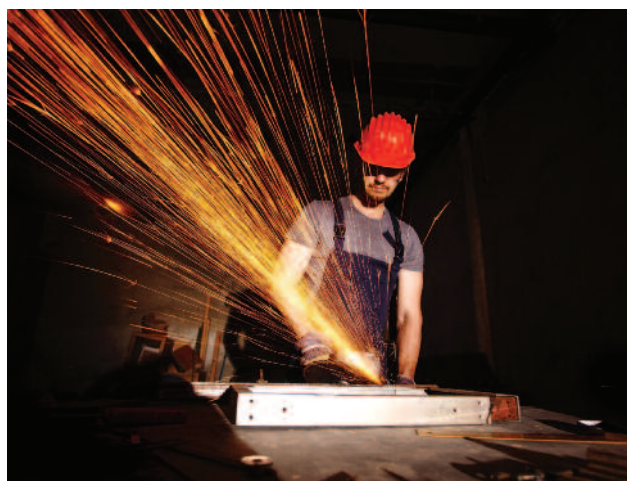
Angle grinding and disc cutting operations should be included in the 'hot work' category because, although the size of incandescent particles produced is generally very much smaller than those produced by welding and flame cutting operations, a stream of grinding or disc cutting sparks landing in the same area of a solid fuel can be sufficient to initiate a smouldering fire. Frictional heating of the work piece may also act as an ignition source, e.g. of oil residues on its surface.

A stream of sparks from disc cutting

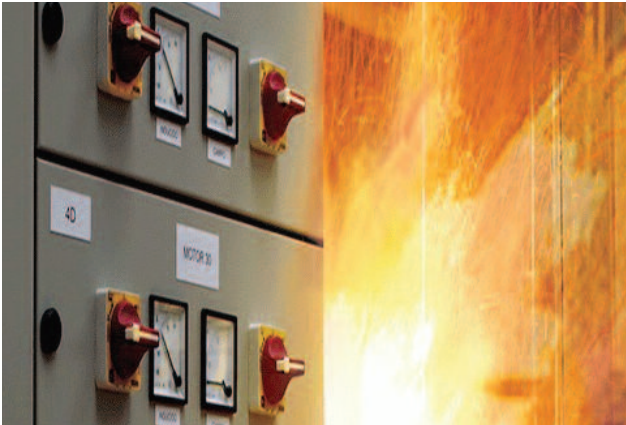
Arc flash incidents can occur where engine room personnel work carelessly on live equipment and cause a short circuit with a tool. No matter how well a person may be trained, distractions, weariness, pressure to restore power, or over-confidence can cause an electrical worker to bypass safety procedures, work unprotected, drop a tool or make contact between energised conductors. This may not only lead to serious injury or death, but also provide a source of ignition for a fire.

Arc flash incident

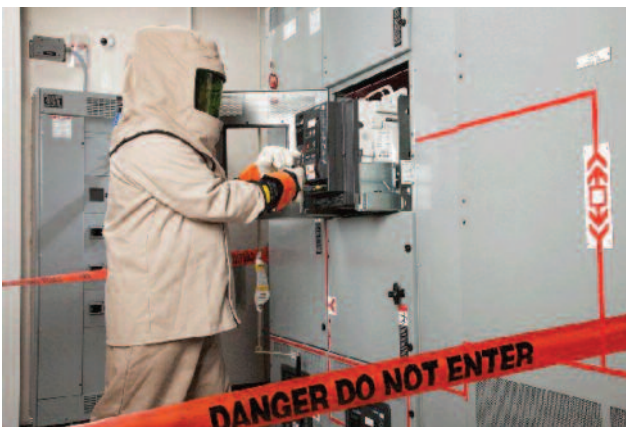
PPE to guard against the effects of arc flash

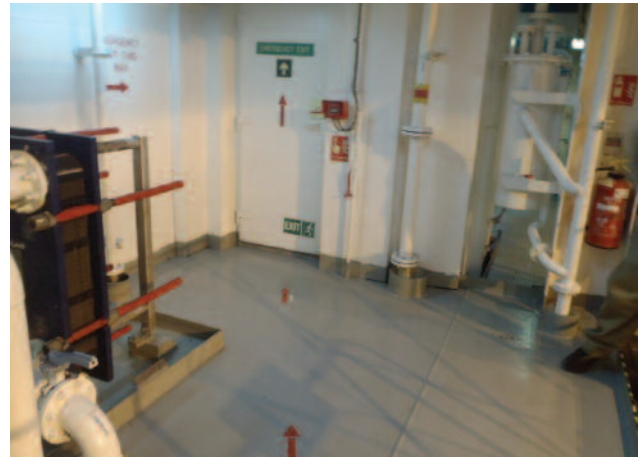
Well marked escape route arrows

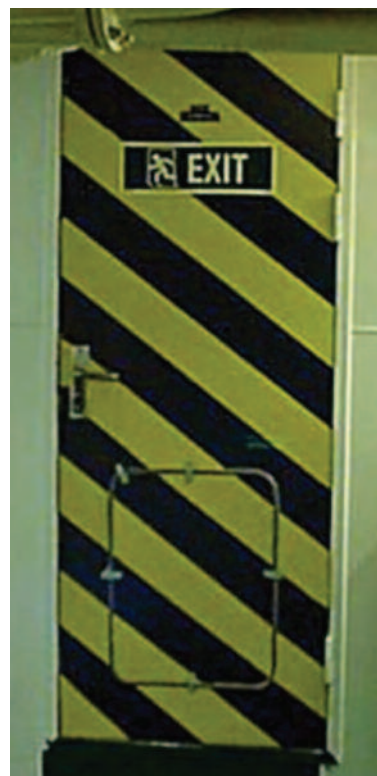
Well marked door

Technical Bulletin No. 39/2007 also recommends that the exit doors are clearly highlighted. In both the above photographs, it can be seen that white painted doors do not stand out well against white painted bulkheads. Doors painted with “tiger stripes” or marked with retro reflective tape are far more obvious.
