Special Edition 2024

LOOKOUT

Containership Collision with Gantry Crane

Navigation Accidents Caused by Defective Voyage Planning

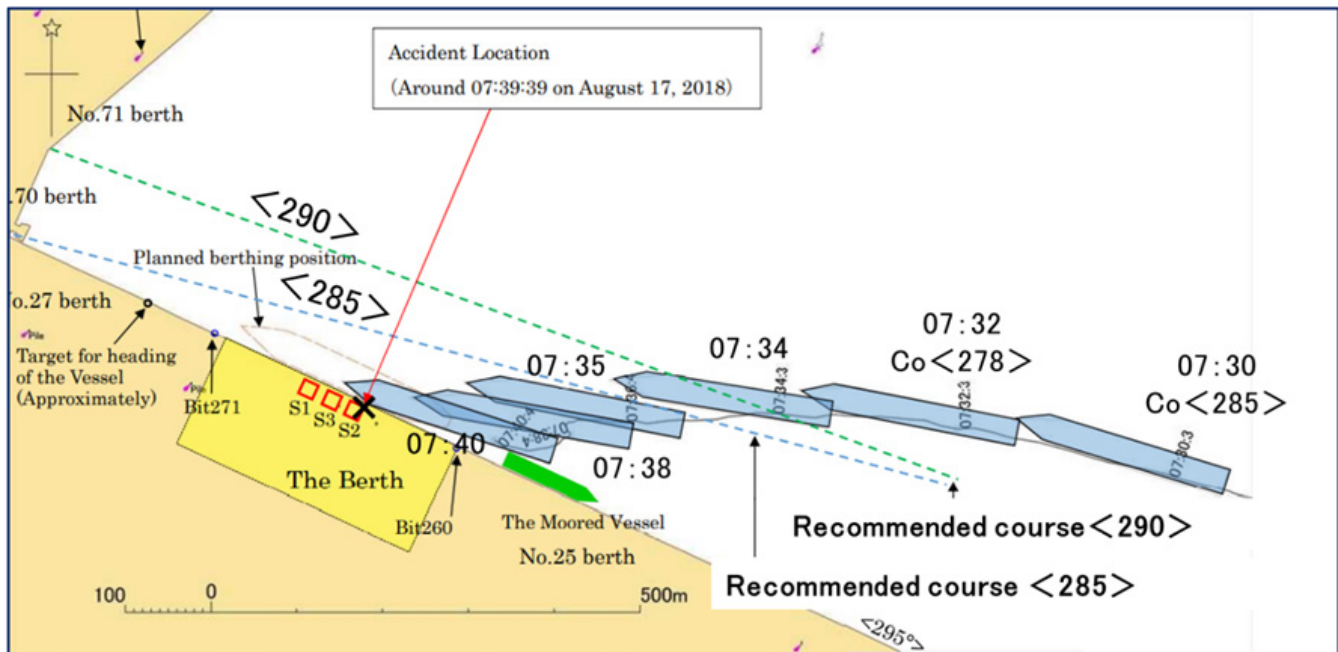
However, a sudden reduction in speed and a strong wind made it impossible to control the vessel's momentum and the vessel collided with a gantry crane on the wharf. This accident damaged the ship's bow, the wharf and gantry crane. Thankfully, there were no injuries or loss of life.

- 0737 At a speed of 1.4 knots, the vessel lost momentum and came close to the moored car carrier. At that time, the bow of the vessel was about 100 metres from the wharf.

- 0738 To avoid colliding with the moored car carrier, the Master ordered full ahead and gave several conning orders.
- 0739 The vessel collided with the gantry crane.

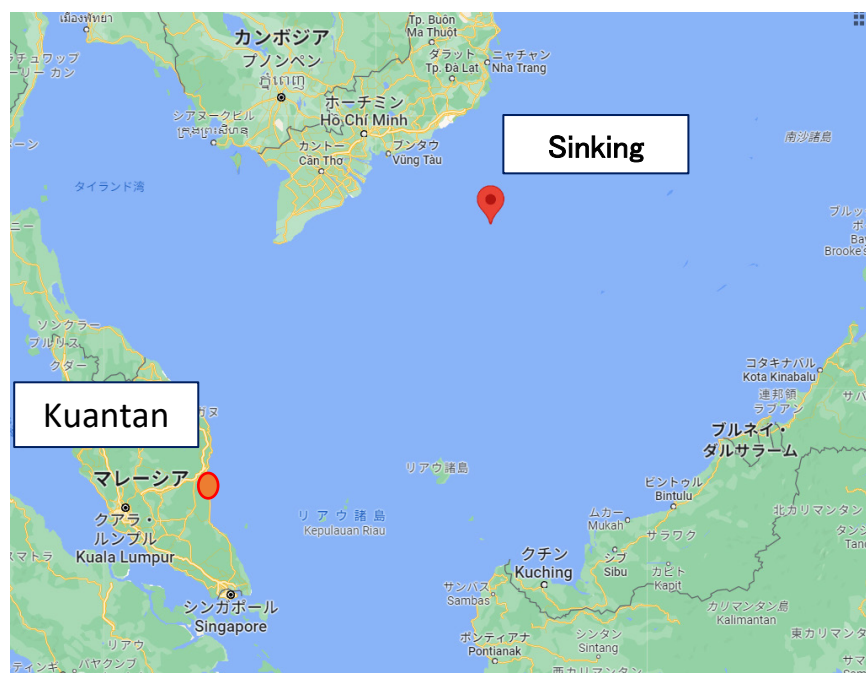
Figure 2: Location where the *Bulk Jupiter* sank

On 2 January, the Japanese Coast Guard received a distress call at 0654 and immediately started a search and rescue operation. The *Bulk Jupiter* reportedly sank between 0654 and 0700. According to the distress call, the ship was approximately 150 nautical miles southeast of Vietnam at 09-01-01 N and 109-15-26 E. At 0945, the containership *Zim Asia* received an emergency call via NAVTEX and began searching for survivors. At 1410, the Master and chief cook were found. At 1556, the tugboat *ONLG Muttrah* rescued the two men, but tragically only the chief cook survived. The *Zim Asia* ended its search and rescue activities on 5 January. The Vietnamese Coast Guard continued searching the area but stopped on 16 January.

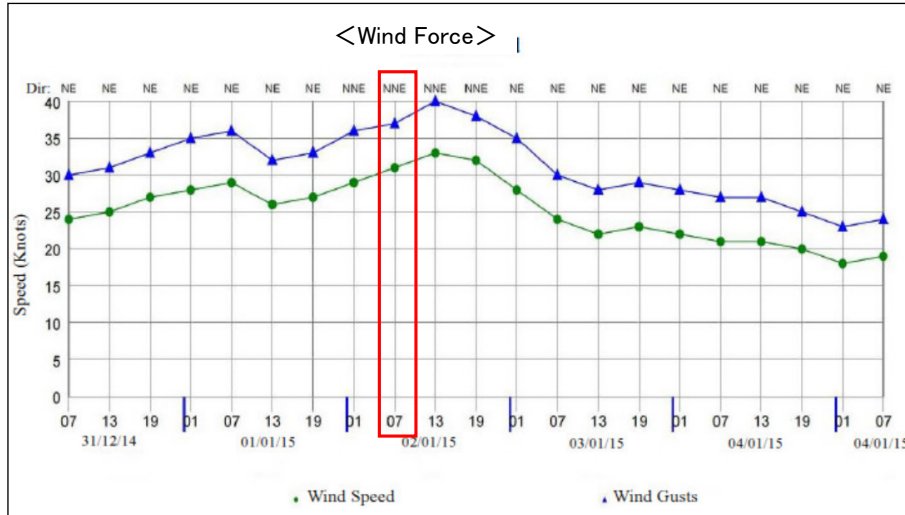
Wind: NNE 31 knots(16m/s~19m/s)

that the *Bulk Jupiter* was rolling and moving up and down violently. Consequently, the possibility of the occurrence of liquefaction cannot be discounted.

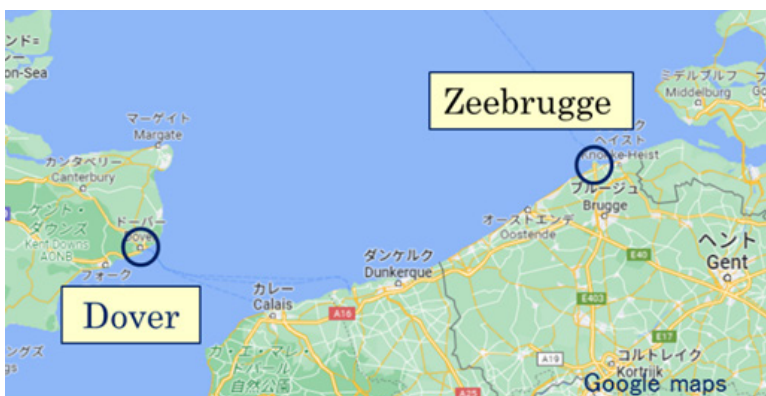
Herald of Free Enterprise

Legal proceedings resulted in the conclusion that there was gross negligence of the captain, chief officer and assistant boatswain concerning the performance of their duties. However, the judgment also stated that there was gross negligence on behalf of the ferry operator. The court made the following statements regarding the management of the ferry operator:
