Chapter 55 – Steel Hatch Covers

This chapter is based on a UK P&I Club report that considered steel hatch covers in general and the MacGregor-Navire hatch covers in particular. It examined claims for seawater damage to cargo carried in ships fitted with steel hatch covers, to analyse the causes of leakage and to suggest solutions.

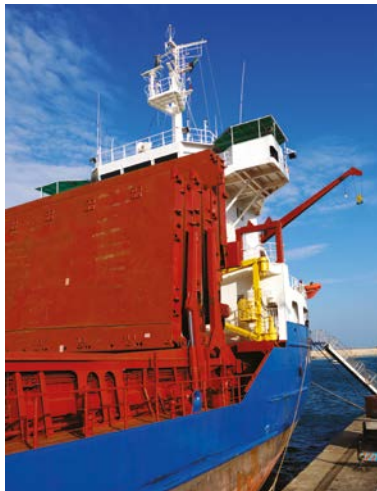
Figure 55.1: Steel hatch covers.

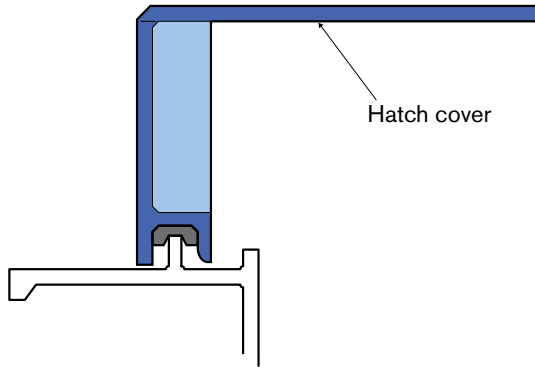
Figure 55.2: Section through side or end of hatch cover.

The sealing round the edge of the hatch, to prevent the ingress of water, consists of a hard rubber gasket strip retained on three sides in a channel bar within the hatch cover

framework and resting on the compression bar, which is a square section steel bar welded onto the coaming bars (see Figures 55.2 to 55.4). A double drainage trough is designed inboard of this compression bar to safeguard against minor localised sealing problems.

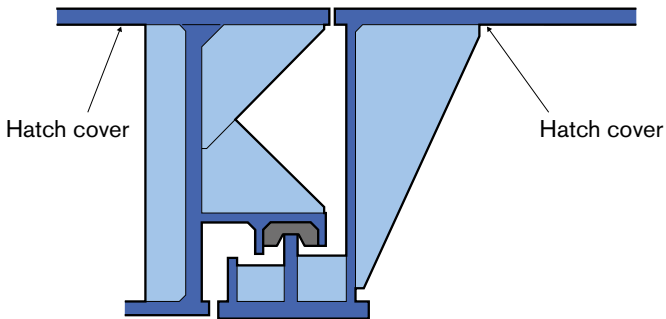
Figure 55.3: Section through cross joint.

This corrosion is particularly likely to affect the compression bars of the cross joints. Close attention should be paid to the cross joints between the panels as, in many instances, leakage has occurred at these joints or at some other position as a result of them being defective in some way. The cross joints must be pressed firmly and evenly together, and the cross wedges, whether manually or automatically operated, are of paramount importance as the tightness of the joint mainly depends on them. If the cross wedges do not provide an effective seal, either the seals have become too heavily compressed and require renewal, the compression bar on the adjacent panel has become bent or worn down, or there is a combination of both these defects. The situation is often rectified by welding a small plate onto the adjacent panel edge at a position where the manual wedge end rides up and over the panels to put pressure on the cross joint. If the wedges become strained or bent, new wedges should be fitted.

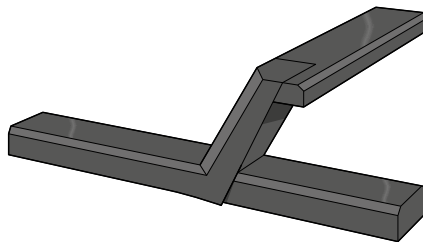
Figure 55.4: Details of cross joint rubber inserts.

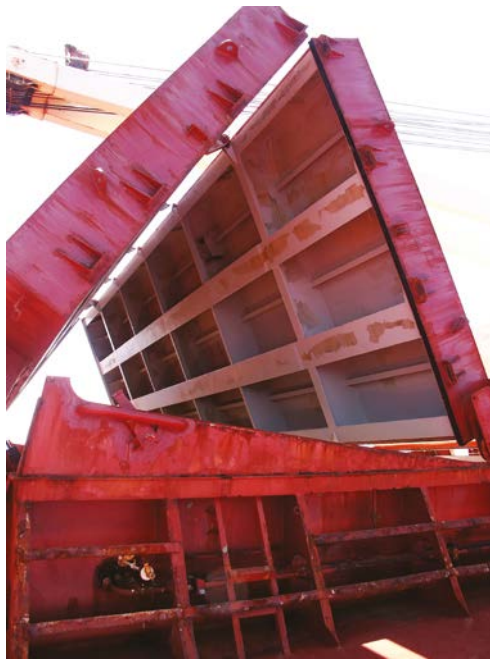
Figure 55.5: Folding hatch cover.

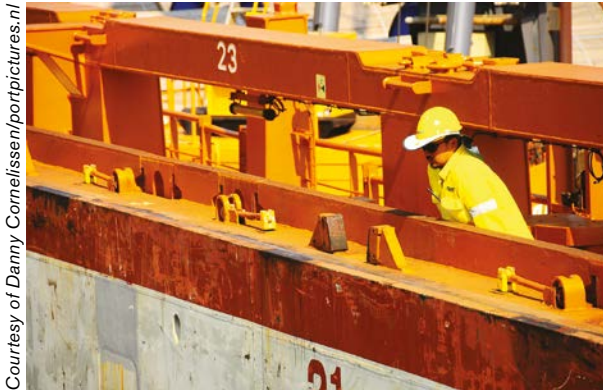
Figure 55.6: Hatch coaming and cleat arrangement on a container ship fitted with pontoons.

The marine environment is extremely corrosive and every opportunity must be taken to minimise its effect, particularly in respect of the cleats that secure the pontoons. It is the shipowner's/operator's responsibility to undertake the required maintenance.

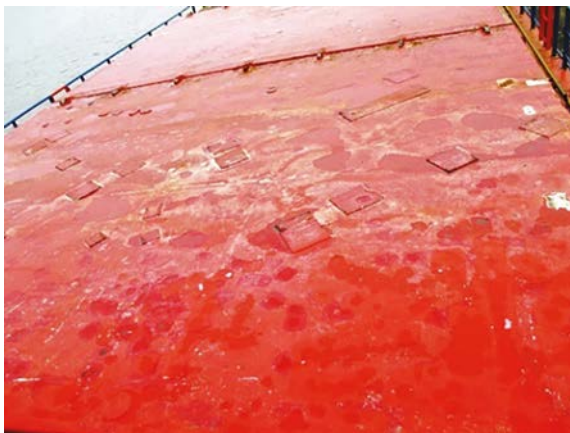
Figure 55.7: Multiple doubler plates on hatch top plating.

Cracks and holes may be repaired with doublers, but these should be considered as a temporary repair and never a substitute for a proper insert repair. Doublers will cover the damage and prevent water ingress, but will not restore the original strength or stop corrosion. Welding on hatch covers should be carried out by trained and qualified personnel as excessive heat may cause distortion of the panel structure, which is very difficult to correct.

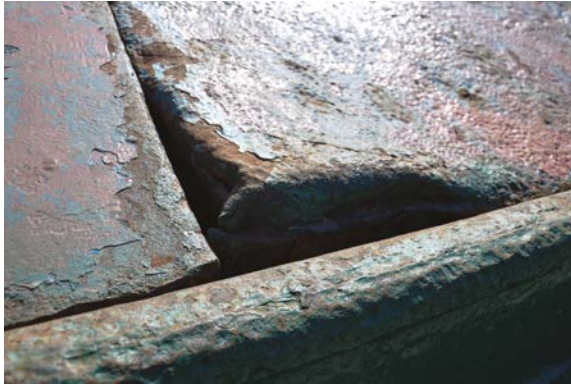
Figure 55.8: Damaged hatch cover which cannot be repaired at sea.

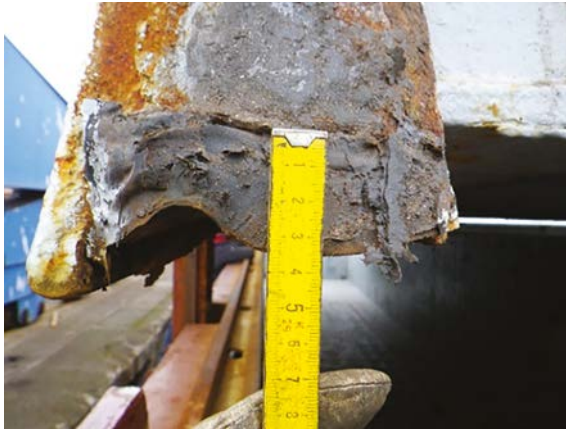
Figure 55.9: Permanent groove in packing rubber caused by overcompression.

Improperly maintained or adjusted hatch covers will generally cause accelerated wear and deep permanent imprint to the rubber seal. Replacing the rubber seal alone will not solve the problem and identifying the root cause of the problem is necessary to ensure that repairs will be efficient.

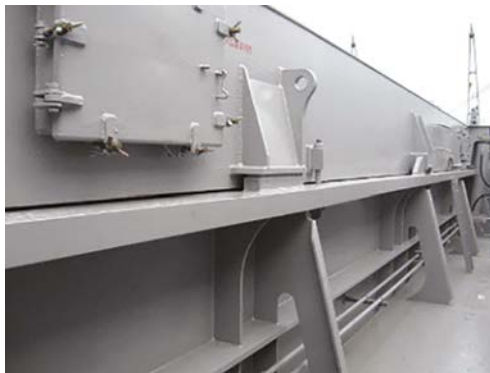
Figure 55.10: Bearing pad.

Bearing pads have two parts, one attached to the side of the hatch cover and the other attached to the coaming. Their purpose is to:

- prevent the hatch cover sitting too low on the coaming
- prevent loads being transferred to other structural parts such as wheels and axles.

Bearing pads come in different sizes and materials and their wear will depend on their position and loads. This means that not all bearing pads will wear down to the same extent simultaneously and they require regular inspection to determine whether allowable wear limits have been exceeded.

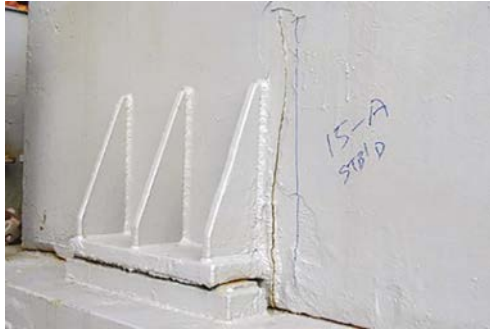
Figure 55.11: A crack developing in the side plating due to advanced bearing pad wear.

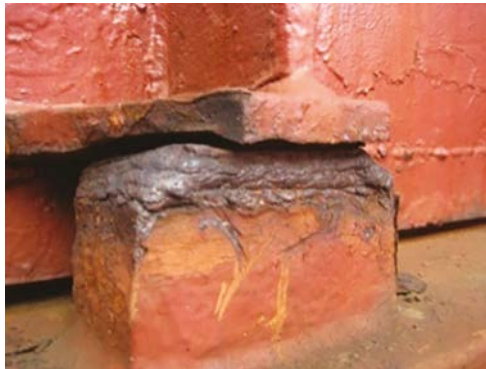
Figure 54.12: Improper repair to a bearing pad.

Care must be taken when replacing bearing pads and it is not just a case of restoring them to their original height. Original spares of the correct size should be used and the two parts must be of compatible materials. Low-friction material is recommended to allow smooth movement between the panel and the coaming. Manufacturers or specialists should be called in for bearing pad adjustment.

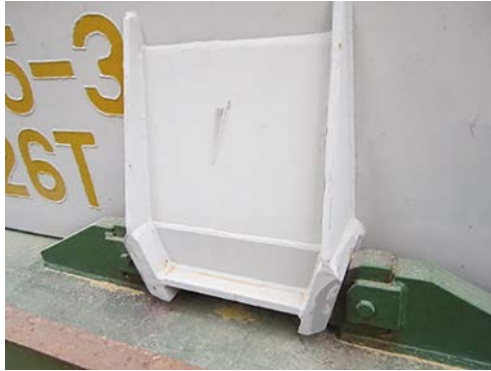
Figure 55.13: Properly maintained and adjusted locator.

Locators guide the panel into its correct closing position and ensure the panels are kept properly positioned during the voyage.

Locator wear should be regularly monitored because slight wear in one place may result in significant loss of compression or improper positioning in another place.

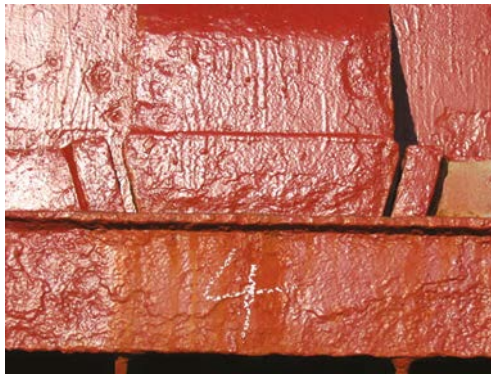
Figure 55.14: Excessive wear on the locator.

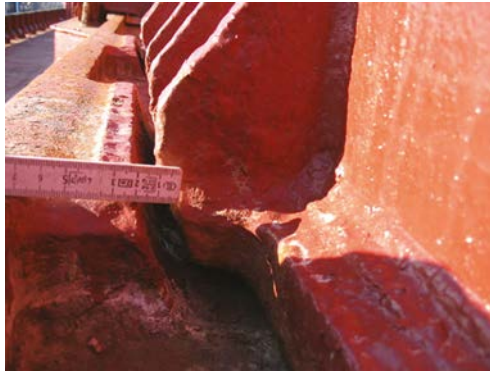
Hatch panels may be subjected to heavy loads and accelerations when the ship is rolling and pitching in a seaway. Stoppers (restraints) are fitted to keep the panel in its correct position. Stopper wear must be closely monitored and the manual should be consulted for advice on allowable wear limits.

Figure 55.15: Stopper.

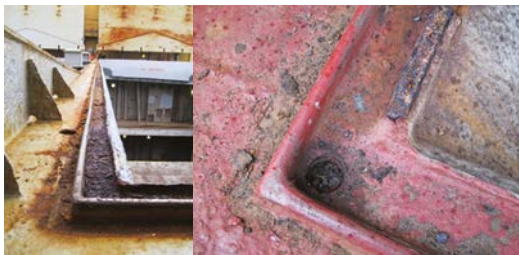
Figure 55.16: Blocked drainage systems.

The coamings and covers of steel hatches are designed to clear away moisture, but general cleanliness of drain holes, waterways and coamings is important because any accumulation of cargo residues or dirt may trap condensation and rainwater. This could result in sweat damage to the cargo and steady deterioration of the covers by corrosion.

Maintenance of the draining system should include regular cleaning of the drainage channels, drain holes, drain pipes and drain valves, particularly following cargo operations.

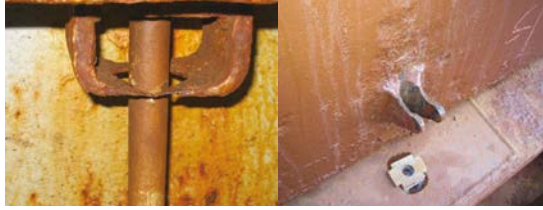
Figure 55.17: Corrosion of quick acting cleat crutch (left), thinned down snugs (right).

The primary function of the securing mechanism (cleats) is to hold the panels down when the ship is at sea. Whatever cleating system is used (eg manual, hydraulically operated), it is vital that it is structurally sound. This includes not only the cleat itself, but also the component parts to which the cleats are engaged (eg coaming table, crutches, snugs/panel side plating). The system should be checked regularly for wear and corrosion.

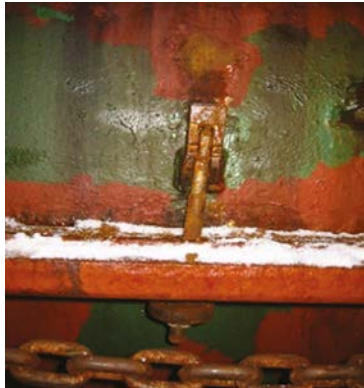
Figure 55.18: Improper vertical alignment of quick acting cleat.

After completion of securing operations, a final check should be made to ensure that the cleats are all in place and correctly positioned. Crooked or poorly fitting cleats may be an indication of improper closing or alignment of the panel. This should be investigated and corrected before commencement of the voyage since faulty securing will affect the holding power of the system.

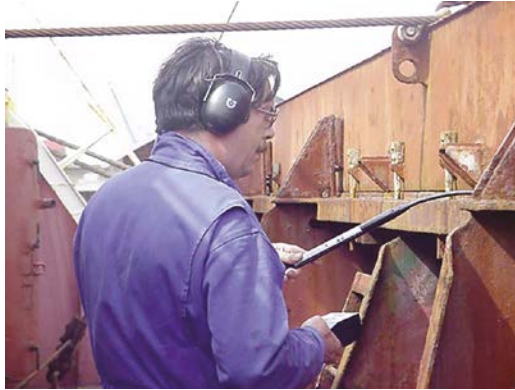
Figure 55.19: Ultrasonic testing of hatch cover.

- The test identifies the exact location and extent of leakage
- it indicates the compression status of the rubber seal; if compression is good, the rubber will be able to compensate for movements at sea and maintain a tight seal
- the equipment is quick and easy to operate. One person operation is possible

- the test may be carried out in loaded or empty holds

- there are no weather/temperature limitations and the test may be carried out during the day or night
- there is no pollution risk.
