## **Technical Bulletin**

**NUMBER 4 2002**

## **Emergency escape breathing devices (EEBD)**

UK Club Inspectors have recently seen sets both wrongly positioned and wrongly marked on many vessels

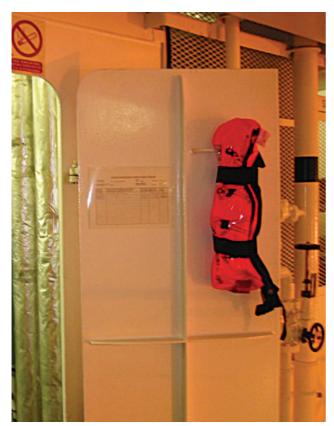
Good position in engine room workshop

Section 4.6 of the circular states:

"Unless personnel are individually carrying EEBDs, consideration should be given for placing such devices

along escape routes within the machinery spaces or at the foot of each escape ladder within the space."
